<b>Reference</b>	SSM72371
<b>Models</b>	Range Rover / L405 Range Rover Sport / L494
<b>Title</b>	Fluid leak from dynamic response roll bar lower level repair
<b>Category</b>	Chassis
<b>Last modified</b>	13-Aug-2015 00:00:00
<b>Symptom</b>	304000 Suspension System
<b>Attachments</b>	image 1.pdf image 2.pdf image 3.pdf

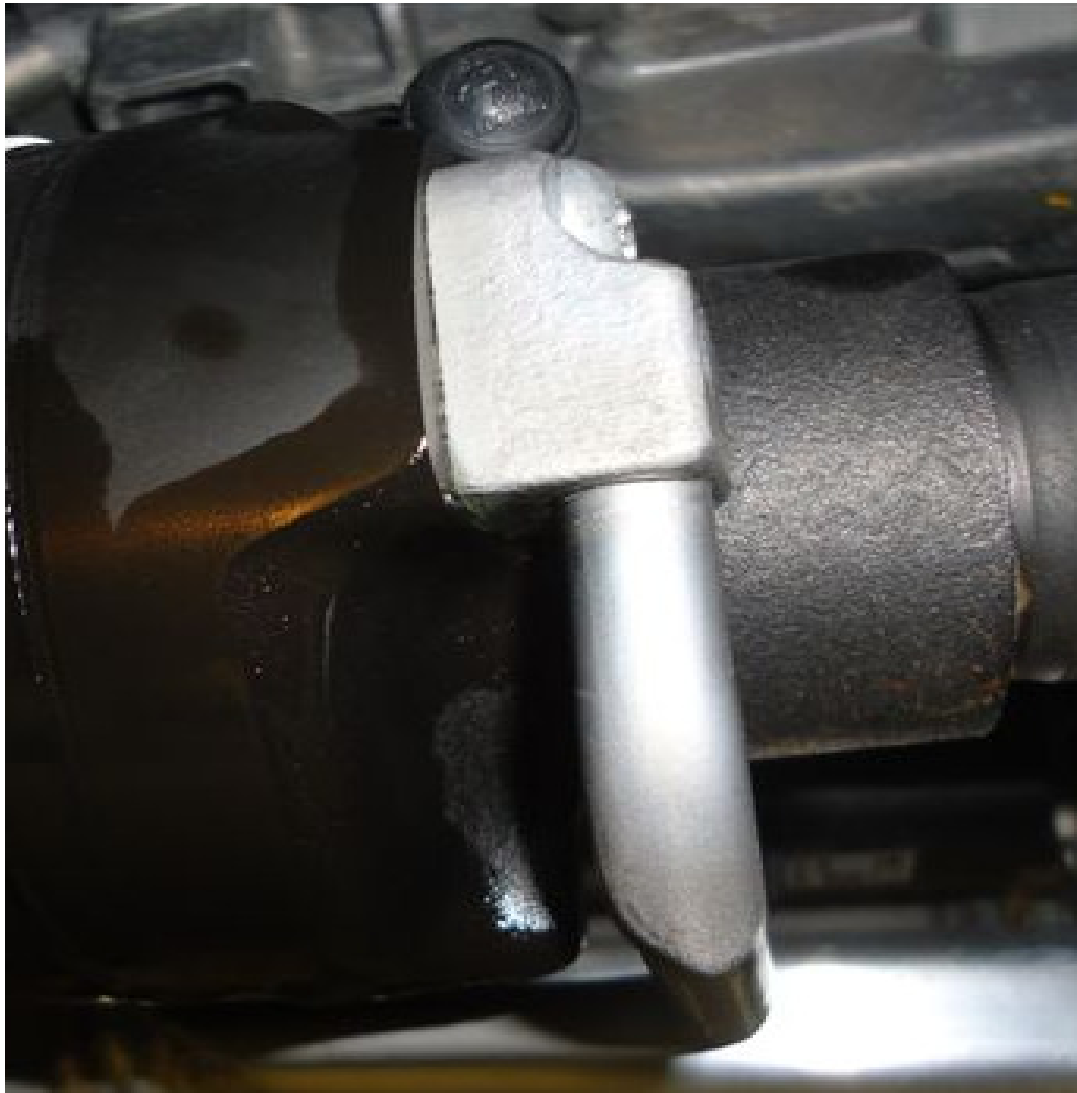
1. If leak is in area of image 1 (pipe to actuator interface) then disassemble joint and inspect o-ring/washer (replace as necessary). Confirm no burrs/sharp edges at end of pipe. Align pipe spigot with actuator and re-assemble. Ensure pipe mounting block is flat to actuator surface and torque to **22Nm**

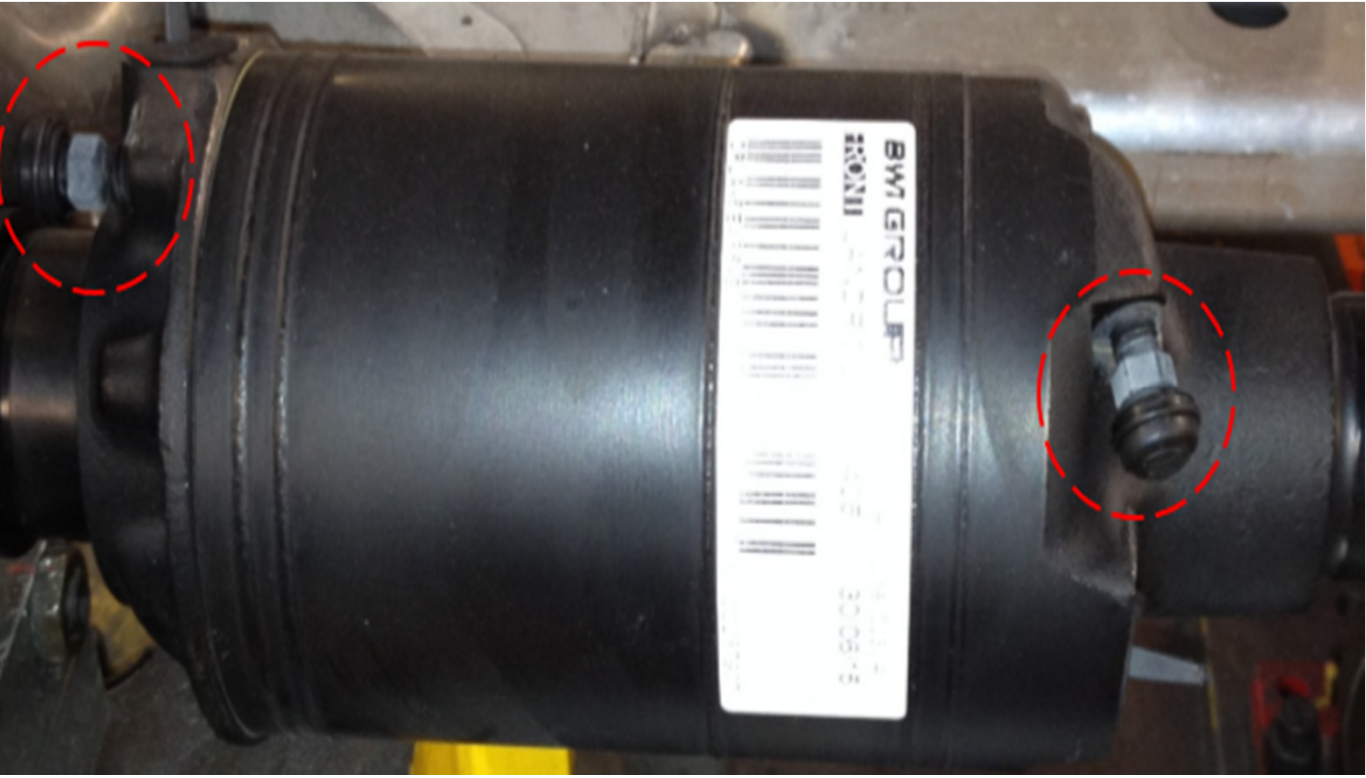
2. If leak is around interface of bleed screw to actuator (as per image 2) then confirm torque is at **15Nm** as per workshop manual (TOPIx).

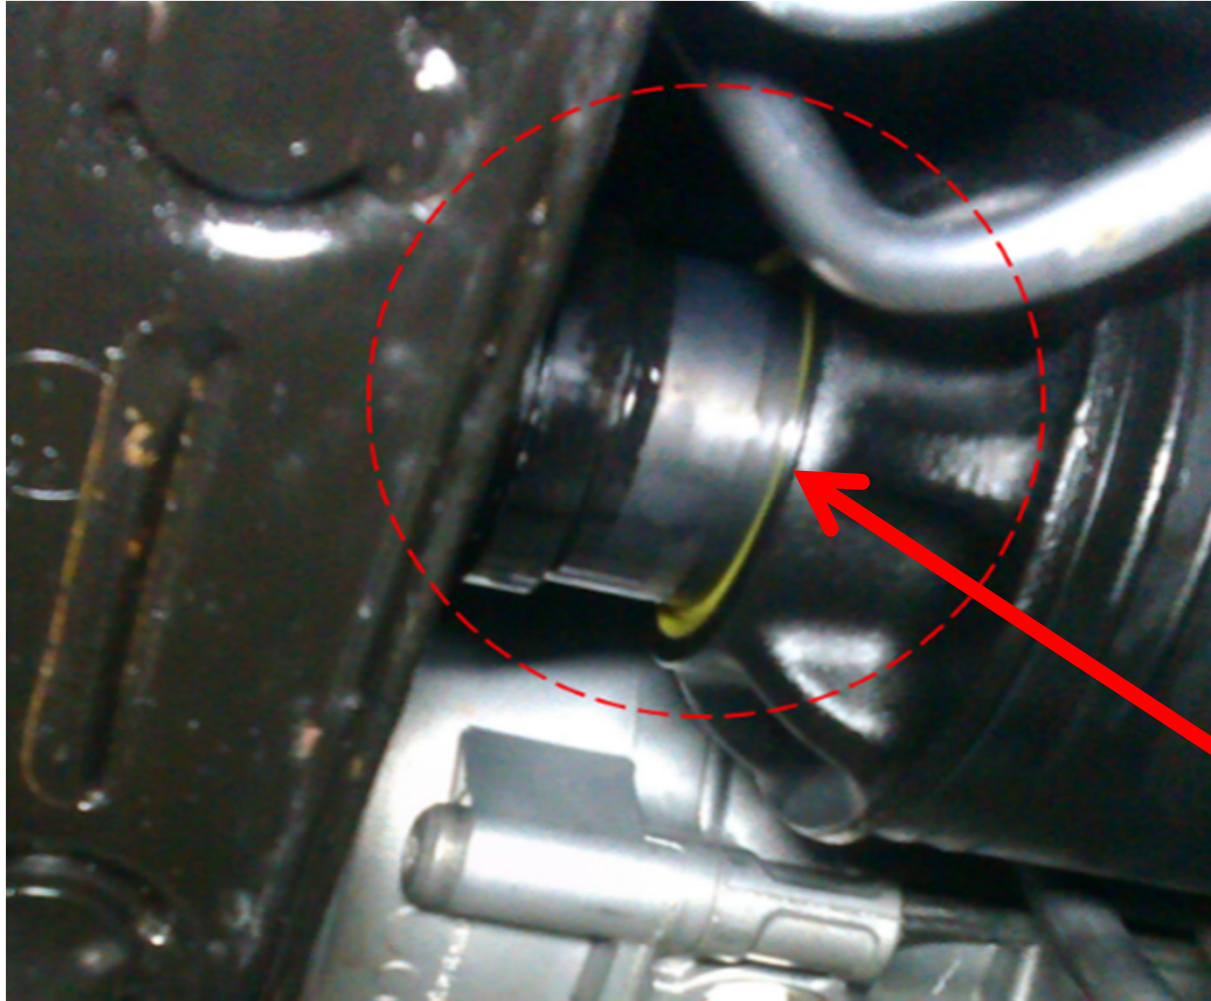
3. If the leak is where the piston shaft comes through the actuator body (image 3) then please take into account it is normal for grease to be present on the piston shaft, this does not constitute a leak. Excessive leakage can suggest that there is damage to the seal.
