TECHNICAL BULLETIN

LTB00819NAS1

'Rattle' Noise From Exhaust System Heat Shield

Discovery Sport (LC)

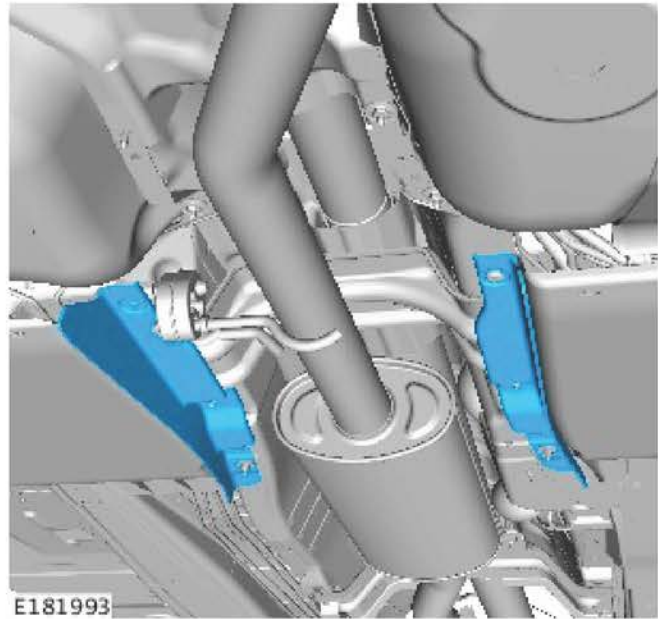
2Verify rattle is from one or both of the exhaust system heat shields.

- If the rattle is from one or both of the exhaust system heat shields, continue to the Service Instruction outlined below.
- If the rattle is not from either of the exhaust system heat shields, rectify as necessary. To be carried out as a separate claim.
 - Continue to the Service Instruction outlined below.
