**TECHNICAL BULLETIN**  
**LTB00823NAS1**  
**28 SEP 2015**

**SECTION: 204-00**

**'Creak' Noise From Stabilizer Bar Bushing-Front**

**Range Rover Evoque (LV)**

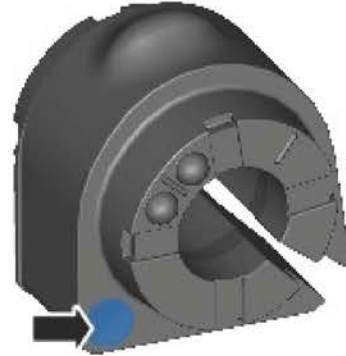
E182199

**NOTE: the new stabilizer bar bushing-front can be identified by a green painted dot in the area shown.**

**CAUTION: lubricant must NOT be used when installing the new stabilizer bar bushing-front.**

Install new stabilizer bar bushings-front (see TOPIX Workshop Manual section 204-01).
