**TECHNICAL BULLETIN**  
**LTB00553NAS2**  
**09 OCT 2015**

**SECTION: 308-07B**

**Transfer Case Noise**

**Range Rover (LG)**

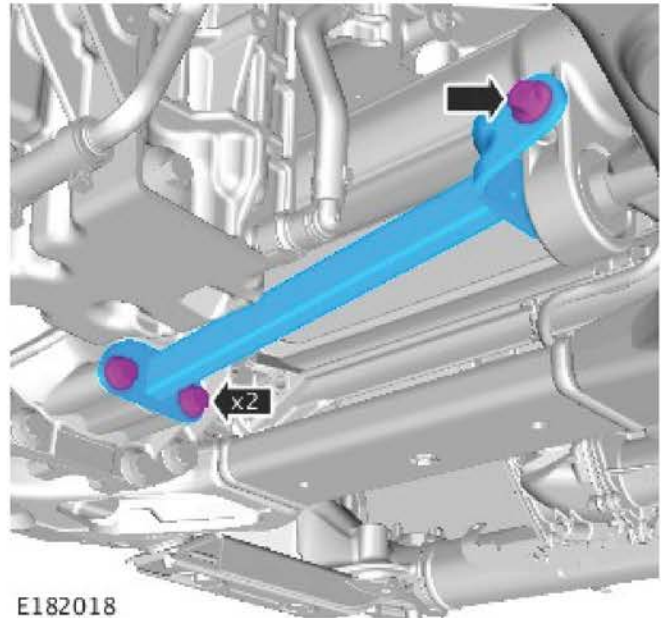
E182018

**NOTE: vehicles with 5.0L NA V8 engine only.**

Install the front differential support bracket.

- Torque: 50Nm.
  - If the noise is no longer coming from the front differential area, no further action is required.
  - If the noise is still coming from the front differential area, continue to the Service Instruction below to renew the transfer case.

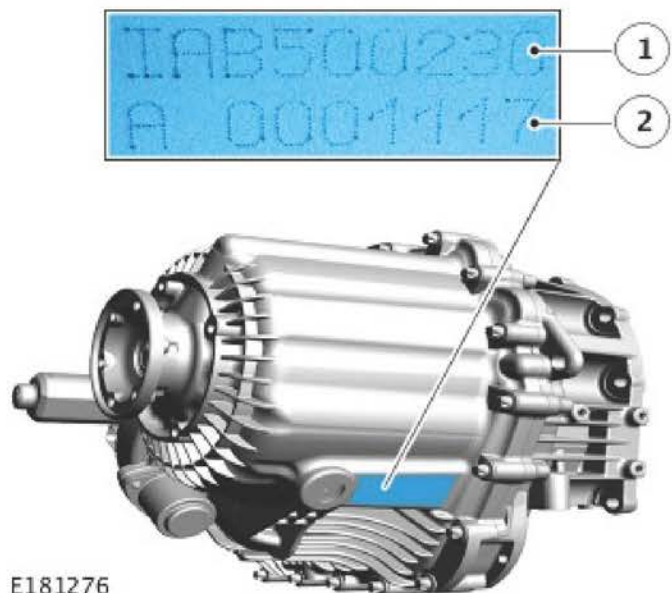
E181276

**NOTE: inspect the serial number on the transfer case ('2'). Make sure the serial number of the transfer case being fitted is post 'A 1025861'.**

Replace the transfer case assembly (see TOPIx Workshop Manual, section 308-07B: Transfer Case).
