TECHNICAL BULLETIN

LTB00753NAS1

Front Seat Cushion Cover Appears Wrinkled

Range Rover Evoque (LV)

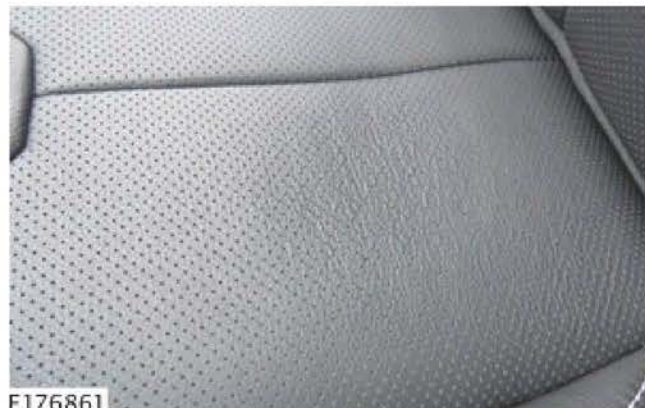
E176861

Cause: This may be caused by variation in the density of the fiber structure within one hide and/or from hide-to-hide creating a wrinkled appearance on laminated leather. The front seat cushion covers insert panels are more susceptible to this issue..

1Example of the defect on a front seat cover.

4Install a new front seat cover (see TOPIx Workshop Manual, section 501-10: Seating).

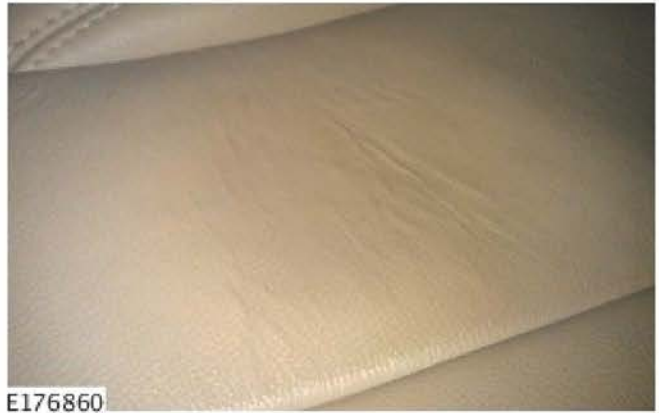
E176860

2Example of the defect on a front seat cover.

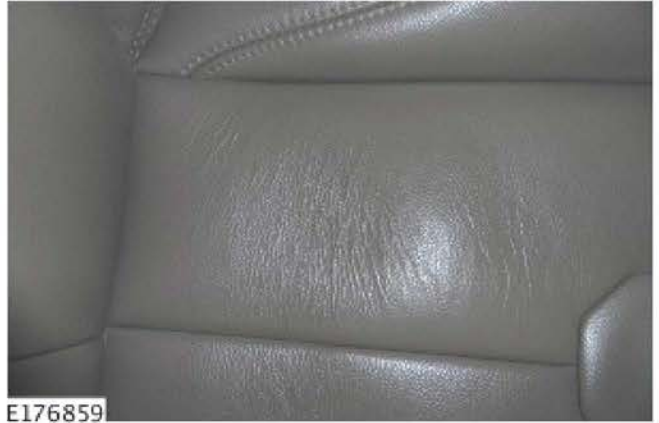
E176859

3Example of the defect on a front seat cover.
