TECHNICAL BULLETIN

LTB00762NAS1

Door Pad / Quarter Trim Panel Insert 'Water Tideline' Evident

Range Rover Evoque (LV)

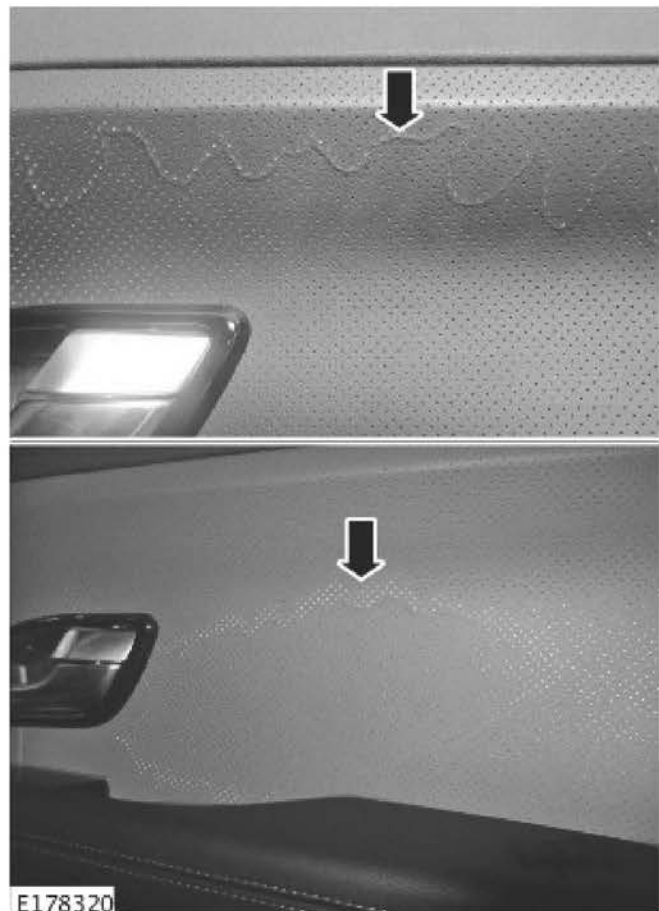
Situation: The perforated leather door pad(s) and/or rear quarter trim panel insert(s) (Coupe only) may exhibit a 'water tideline'.

Cause: This may be caused by water entering the door pad insert via the open pores in the perforations of the leather.

1 Check for evidence of a 'water tideline'.

Install a new front door trim panel, (see TOPIx Workshop Manual section 501-05: Interior Trim and Ornamentation - Front Door Trim Panel).

5-door only: install a new rear door trim panel, (see TOPIx Workshop Manual section 501-05: Interior

Coupe only: install a new rear quarter trim panel, (see TOPIx Workshop Manual section 501-05: Interior Trim and Ornamentation - Rear quarter Trim Panel).
