TECHNICAL BULLETIN

LTB00780NAS1

SECTION: 303-00

Primary Drive Belt Idler Pulley 'Humming' Noise

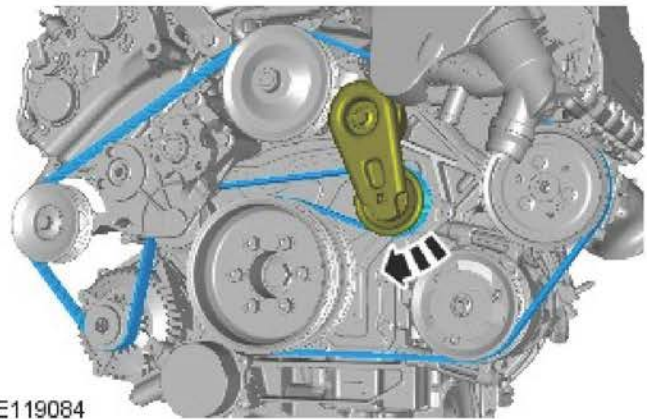
2 **△ NOTE: note the fitted position of the primary drive belt.**

Loosen the primary drive belt and remove from the idler pulley.

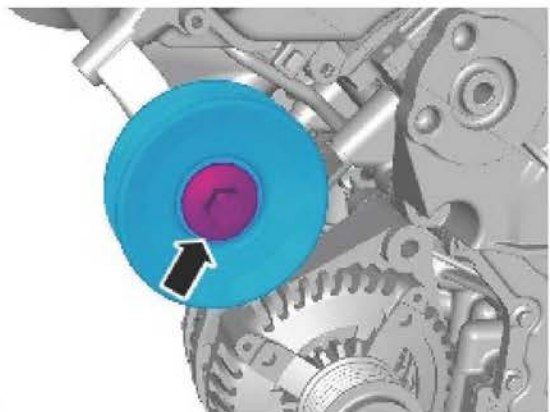
3 Remove the primary drive belt idler pulley cap.

- Remove and discard the idler pulley.

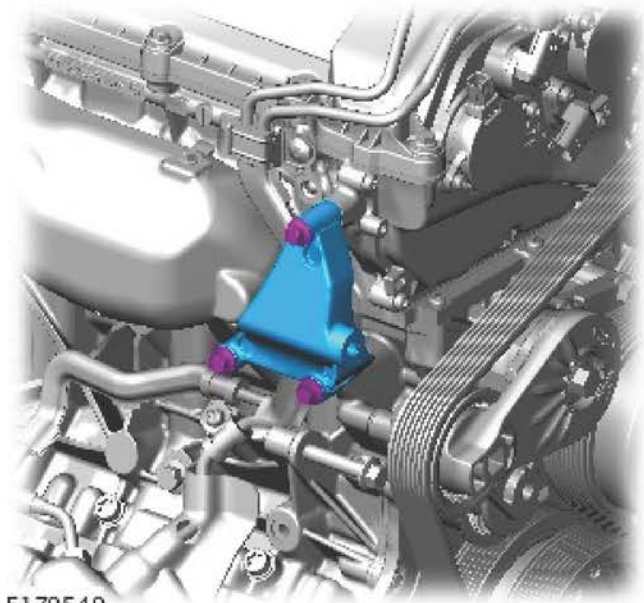
E179549

- 4 Remove the primary drive belt idler pulley bracket.
