TECHNICAL BULLETIN
LTB00762NAS2
25 NOV 2015

Door Pad / Quarter Trim Panel Insert 'Water Tideline' Evident

Range Rover Evoque (LV)

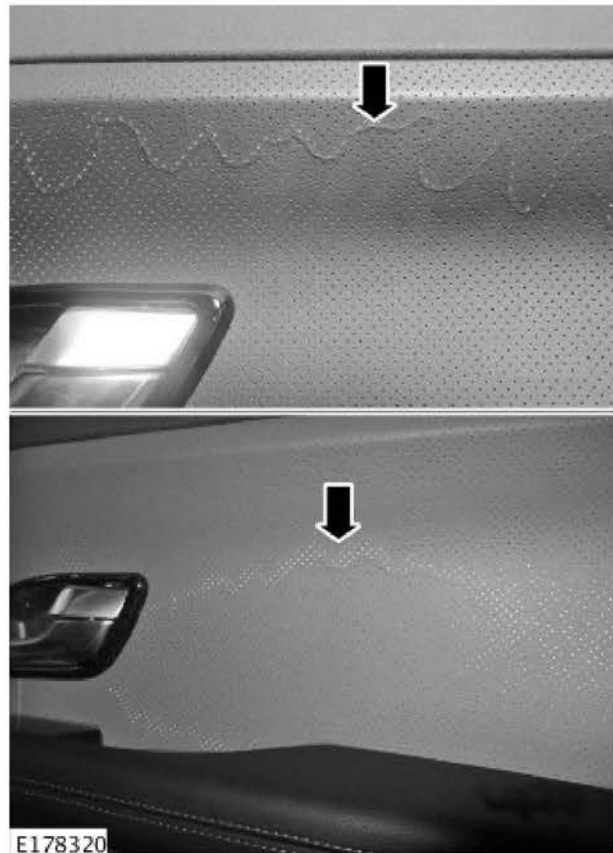
Situation: The perforated leather door pad(s) and/or rear quarter trim panel insert(s) (Coupe only) may exhibit a 'water tideline'.

Cause: This may be caused by water entering the door pad insert via the open pores in the perforations of the leather.

1Check for evidence of a 'water tideline'.

Install a new front door trim panel (see TOPIx Workshop Manual section 501-05: Interior Trim and Ornamentation - Front Door Trim Panel).

5-door only: install a new rear door trim panel (see TOPIx Workshop Manual section 501-05: Interior Trim and Ornamentation - Rear Door Trim Panel).

Coupe only: install a new rear quarter trim panel (see TOPIx Workshop Manual section 501-05: Interior Trim and Ornamentation - Rear quarter Trim Panel).
