TECHNICAL BULLETIN

LTB00834NAS1

Active Driveline Power Transfer Unit Weeping Oil

Range Rover Evoque (LV)

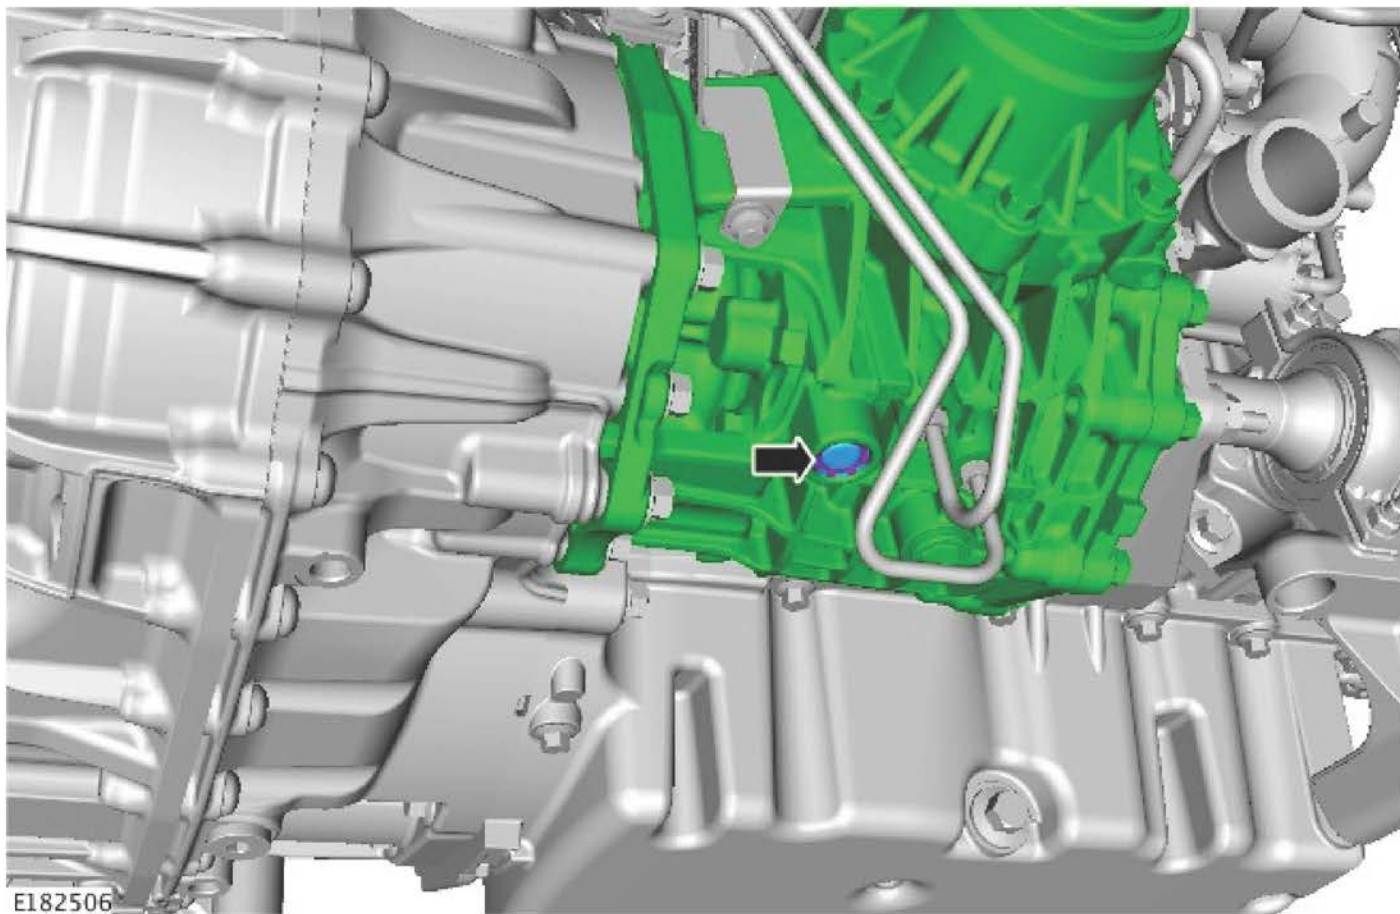
Situation: Upon routine maintenance, a technician may find oil weeping from the Active Driveline Power Transfer Unit (PTU).

Cause: This may be caused by oil weeping from the detent sealing cap.

1 When carrying out routine maintenance a technician may find oil weeping from the Active Driveline Power Transfer Unit (PTU). If the oil weep is found to be leaking from the PTU detent cap it can now be installed as a lower level component.

- If the PTU detent cap is found to be weeping follow the Service Instruction below.
