TECHNICAL BULLETIN
LTB00845NAS1
11 NOV 2015

SECTION: 418-00

Smart Key Does Not Unlock the Vehicle

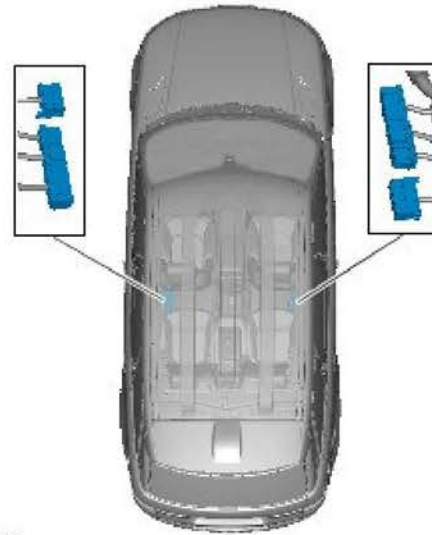
E184529

Cause: This may be caused by corrosion at the rear seat module connector located in the rear passenger footwells.

1 Component location.

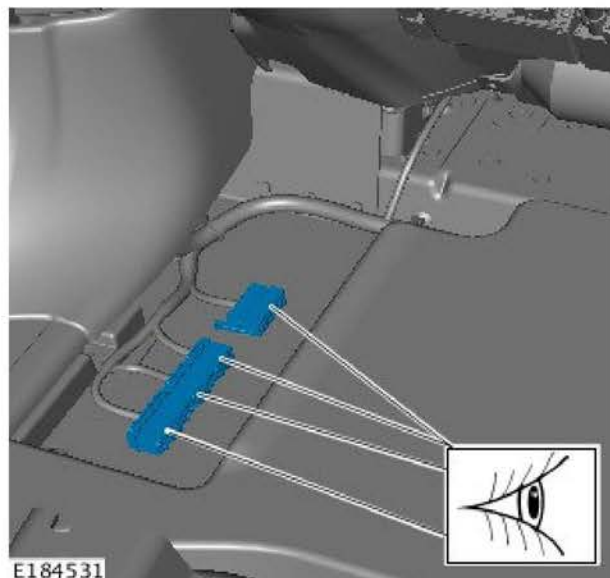
Check the following terminals for signs of corrosion:

- Range Rover Sport - rear left-hand footwell - C3PS186 A/B/C/D
- Range Rover Sport - rear right-hand footwell - C3PS185 A/B/C/D
- Range Rover - rear left-hand footwell - C3PS146 A/B/C/D
- Range Rover - rear right-hand footwell - C3PS145 A/B/C/D.

- If no corrosion is evident in any connector, continue with normal diagnosis. Use SDD with reference to TOPIX.
- Once rectified, reverse step 1 to install the rear passenger footwell carpets.
- If corrosion is evident in any connector, continue to the next step.
