TECHNICAL BULLETIN
LTB00846NAS1
25 NOV 2015

SECTION: 501-05

Front/Rear Door Interior Trim Panel Detached

Discovery Sport (LC)

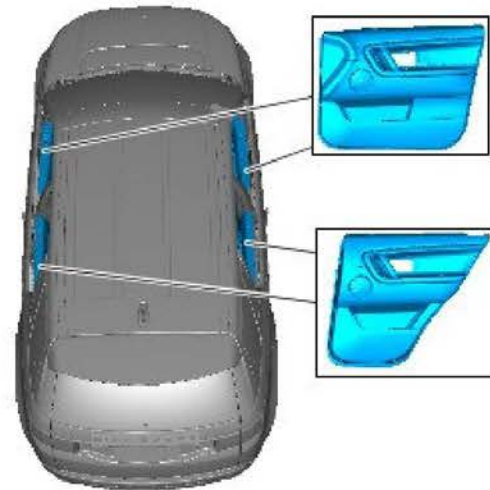
E185592

1 Component location.

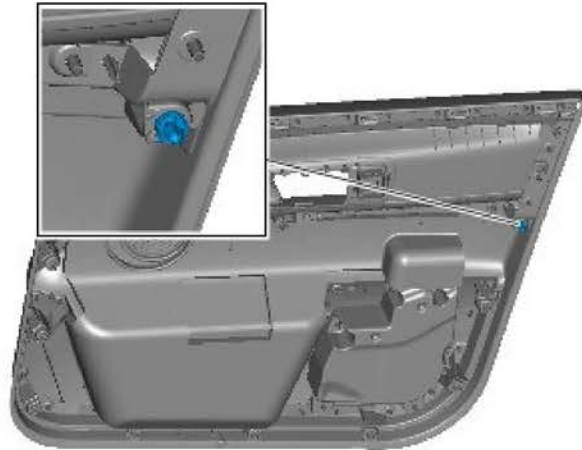
E184763

**NOTE: front right door interior trim panel shown; front left door interior trim panel similar.**

Remove and discard the lantern clip.

- Install the new 'orange' clip.

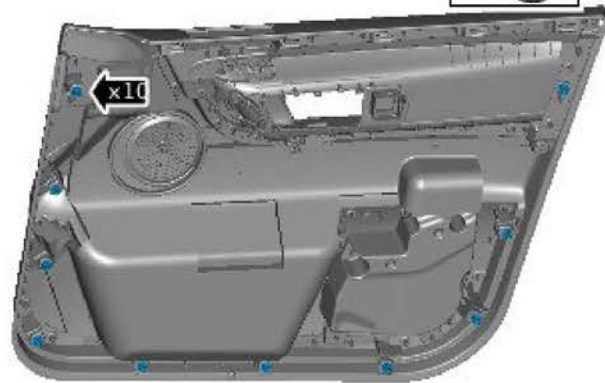
E184764

**NOTE: front right door interior trim panel shown; front left door interior trim panel similar.**

Remove and discard the 10 remaining clips from the door trim.

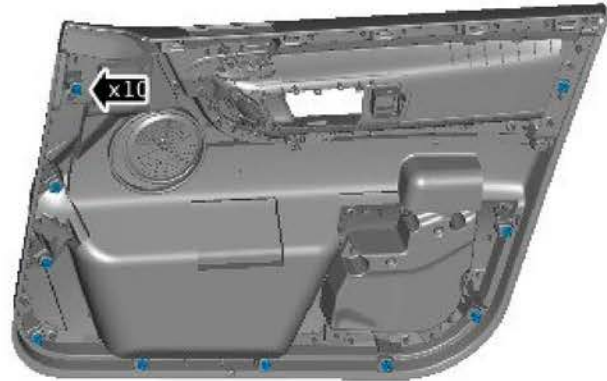
E184770

**NOTE: front right door interior trim panel shown; front left door interior trim panel similar.**

Fit the 10 new clips to the door trim.

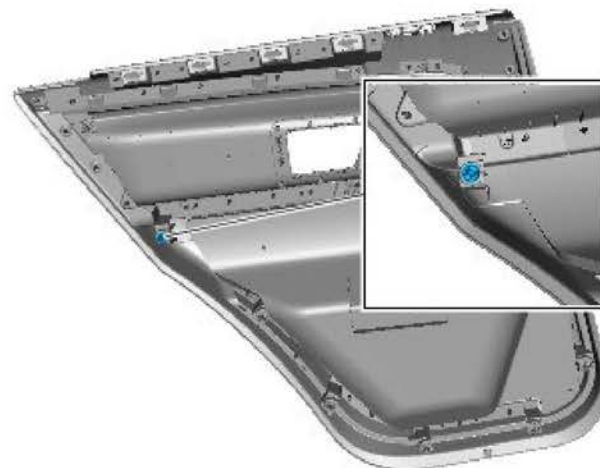
E185593

**NOTE: rear right door trim panel shown; rear left door trim panel similar.**

Remove and discard the lantern clip and install the new 'orange' clip.
