TECHNICAL BULLETIN
LTB00853NAS1
19 NOV 2015

SECTION: 205-01

"Rattle" Noise From Driveshaft Heat Shield

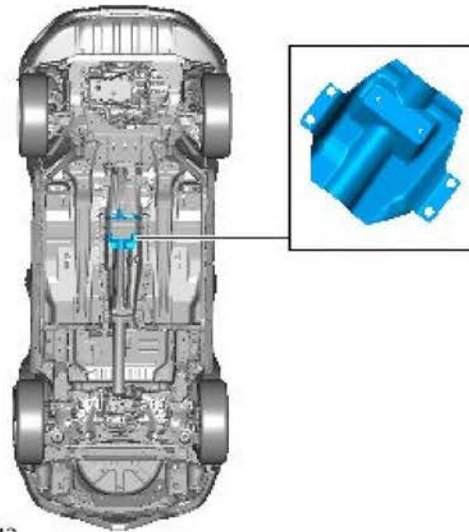
E184942

Situation: A "rattle" noise from the engine compartment or from the underbody area may be evident.

Cause: This may be caused by reduced clearance between the driveshaft-rear and the driveshaft-rear heat shield.

1 Component location.
