Reference	SSM72541
Models	Range Rover Sport / L320
Title	L320 Range Rover Sport Wheel Arch Finishers Corroded or Mis -shaped
Category	Body
Last modified	26-Nov-2015 00:00:00
Symptom	108000 Ext. Trim/Accessories
Attachments	L320 Wheel Arch Finisher.pdf (L320 Wheel Arch Finisher.pdf)

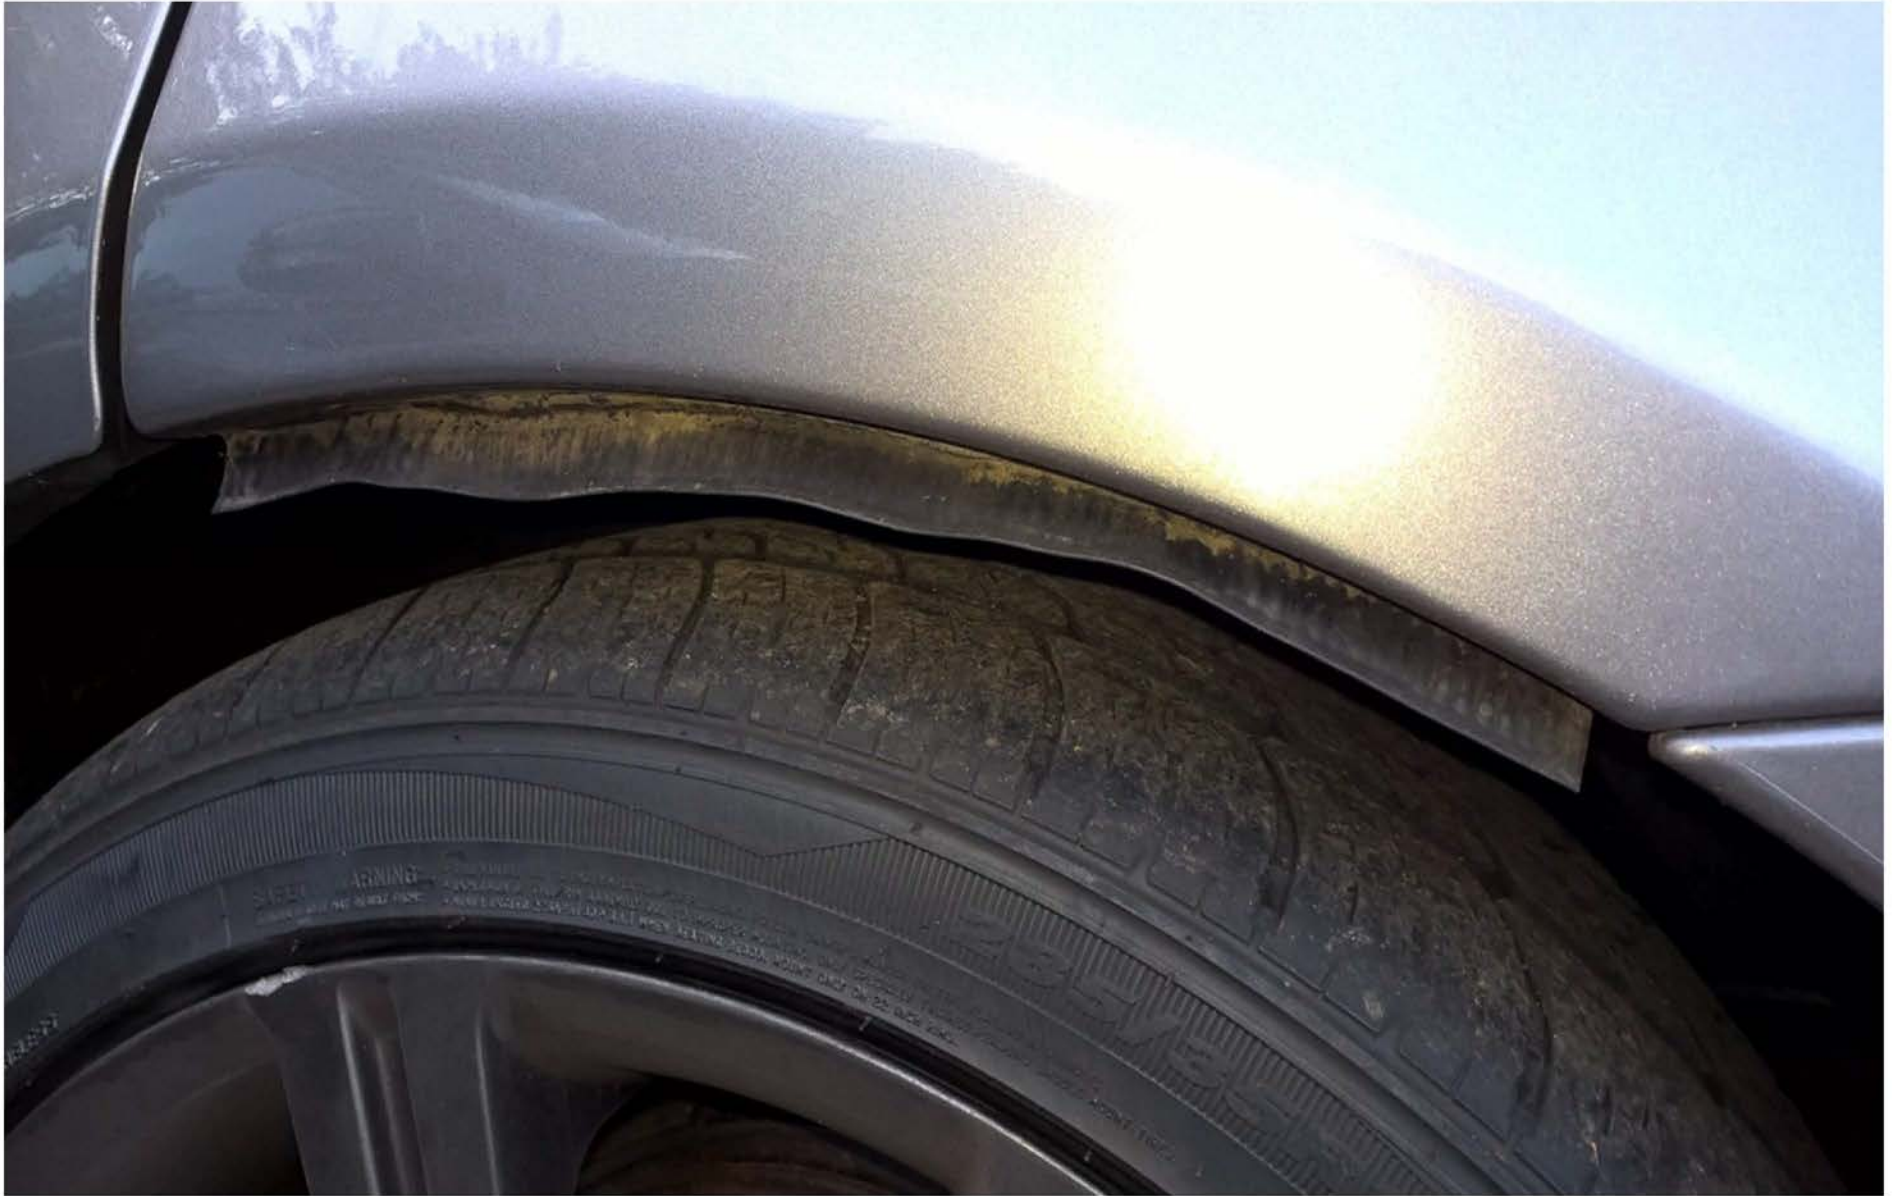
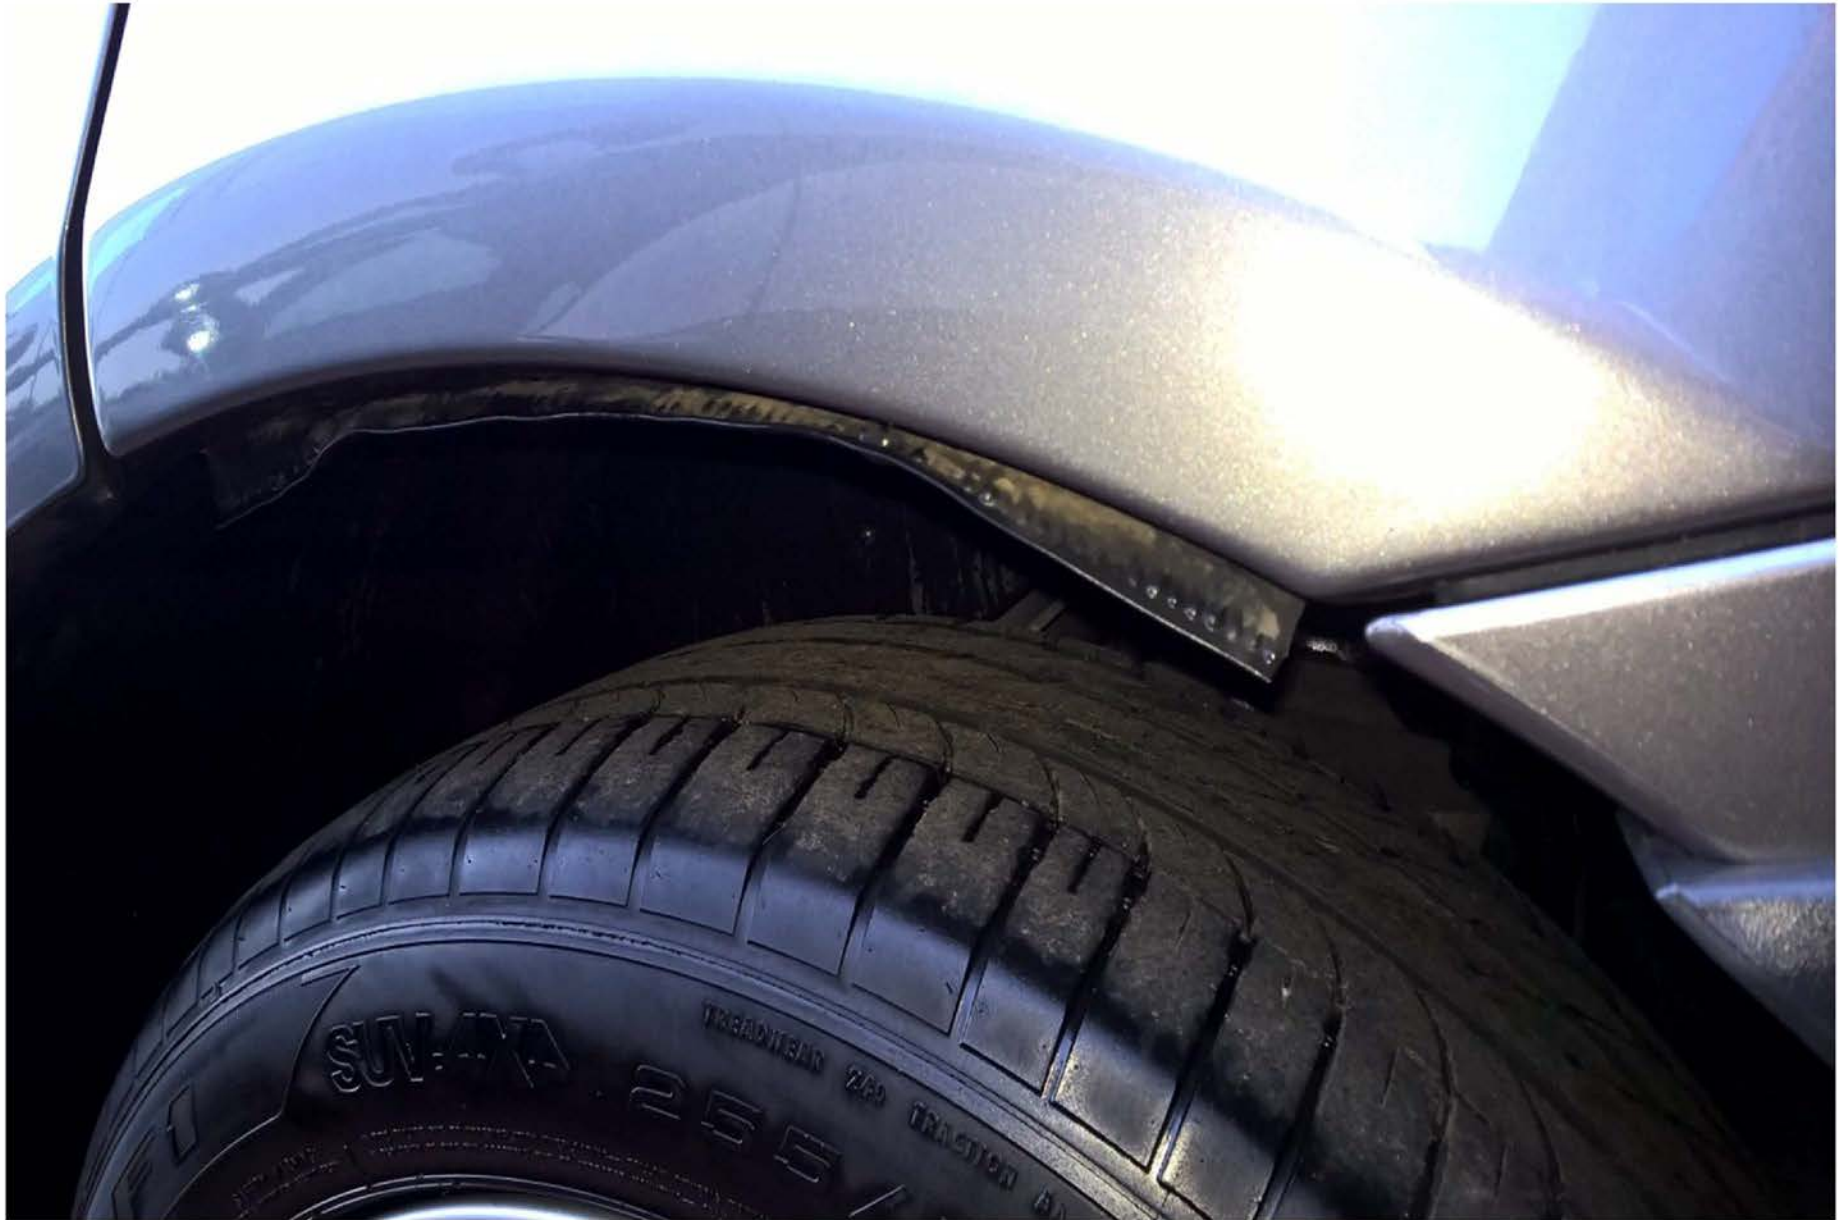
L320 Range Rover Sport Customers may report that either of or both Rear Wheel Arch Finishers have corroded or become mis-shaped – See attached photo's

Corrosion and thus structural failure of the internal aluminium carrier causes the part to distort and potentially come adrift

With this in mind should a customer report this concern then you are asked to remove both Wheel Arch Finishers (Part No. CLB500061) to maintain a symmetrical appearance and replacement is not required.
