Reference	SSM72545
Models	LR4 / L319 Range Rover / L405 Range Rover Sport / L494
Title	16MY 3.0 AJ126 and 5.0 AJ133 Gasoline Oxygen Sensors
Category	Driveability
Last modified	30-Nov-2015 00:00:00
Symptom	698298 Malfunction Indicator Lamp
Attachments	Oxygen Sensor.pdf (Oxygen Sensor.pdf)
Content	<p><u>Issue:</u> Early life oxygen sensor concerns on 2016 Model Year vehicles, affecting Range Rover (LG), Range Rover Sport (LW) and Discovery 4/LR4 (LA) fitted with either the 3.0SC AJ126 or 5.0NA/SC AJ133 engines.</p> <p><u>Cause:</u> Parts quality issue (operational failure at supplier during manufacture of the sensor).</p> <p><u>Action:</u> If the above issue is verified, before fitting the new oxygen sensor please check the country of manufacture stamped on the body of the sensor.</p> <p>If the country of manufacture states Germany the sensor is ok to fit.</p> <p>If the country of manufacture states Brasil then the manufacturing date code on the sensor needs to be checked prior to fitment. If the code reads 554, 555, 556 or 557 the sensor must not be fitted to the vehicle.</p> <p>A stock check is being carried out at Neovia to quarantine any affected sensors.</p> <p>Refer to the atta

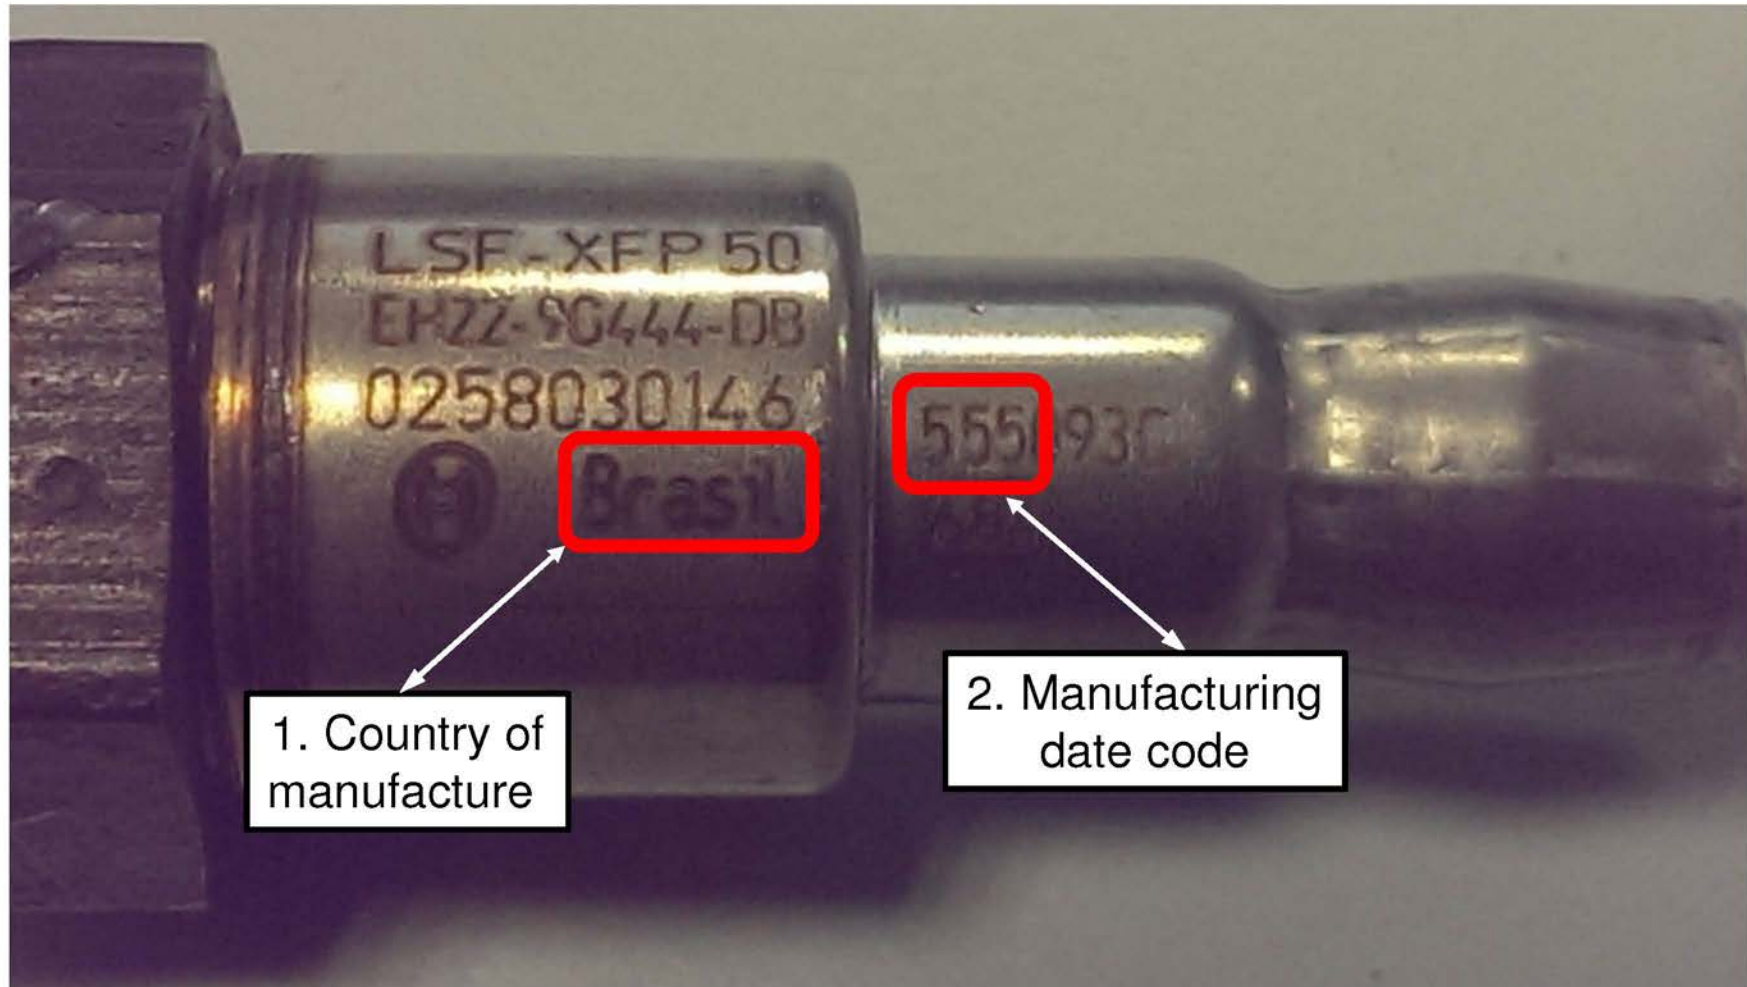
1. Look for country – **Brasil**
2. Look at the first three digits of the date code. If the code reads **554**, **555**, **556** or **557** the sensor must **NOT** be fitted to the vehicle.
