TECHNICAL BULLETIN

LTB00710NAS3
22 DEC 2015

SECTION: 303-04C

Metallic 'Clicking' / 'Rasping' Noise From The Engine

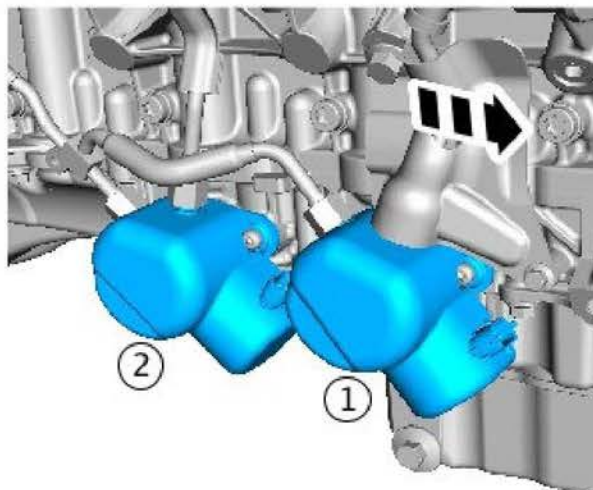
E175872

Situation: A metallic 'clicking' / 'rasping' noise may be evident from the engine. The noise may be more noticeable when the engine is at idle speed and when the engine is cold.

Cause: This may be caused by a noisy high pressure fuel pump outlet valve.

The illustration shows the high pressure fuel pumps and their possible alternate designation.

- Pump 1: front
- Pump 2: rear

15Install new high pressure fuel pump(s) as per diagnostics results (see TOPIx workshop Manual, section 303-04C: Fuel Charging and Controls - V6 S/C 3.0L Petrol).
