TECHNICAL BULLETIN
LTB00780NAS2
10 DEC 2015

SECTION: 303-00

Accessory Drive Belt Idler Pulley 'Humming' Noise

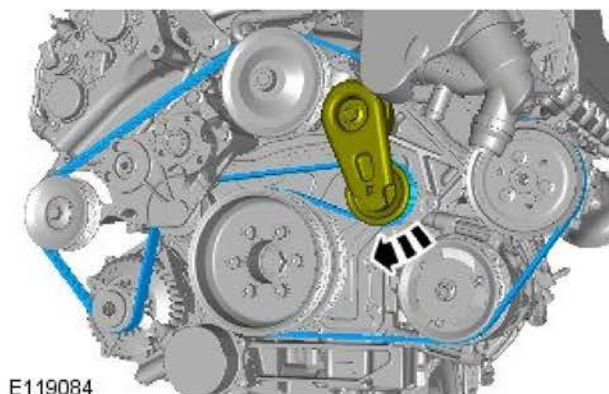
Loosen the accessory drive belt and remove from the idler pulley.

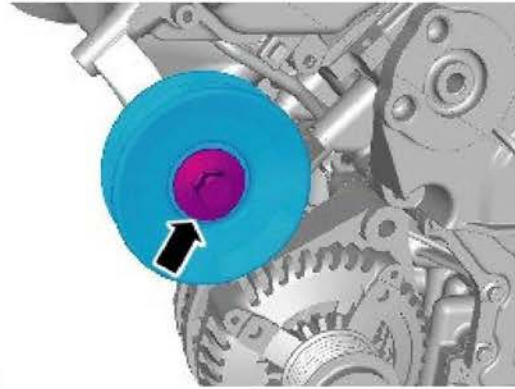
E119223

3 Remove the accessory drive belt idler pulley cap.

- Remove and discard the idler pulley.

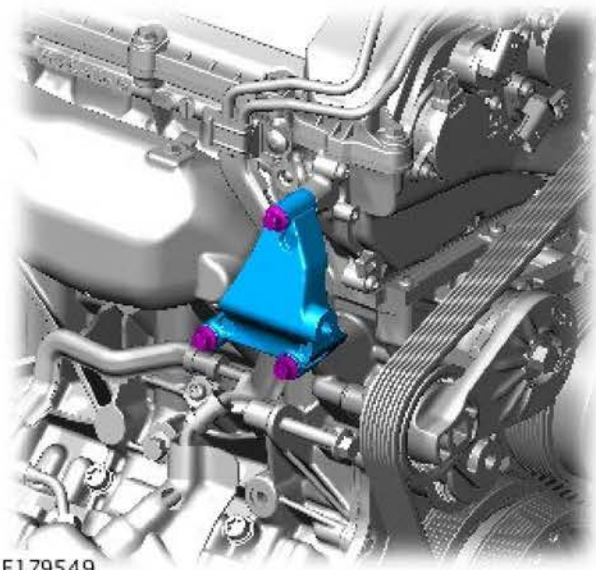
E179549

- 4 Remove the accessory drive belt idler pulley bracket.

- 5 Install the new accessory drive belt pulley bracket.

- Torque: 25Nm

- 6 Install the new accessory drive belt idler pulley.

- Torque: 47Nm
