TECHNICAL BULLETIN LTB00865NAS1 10 DEC 2015

Roof Moulding Loose / Adrift

Discovery Sport (LC)

2015 Onwards Model Year: VIN: 500429 Onwards Manufacturing Plant: Halewood

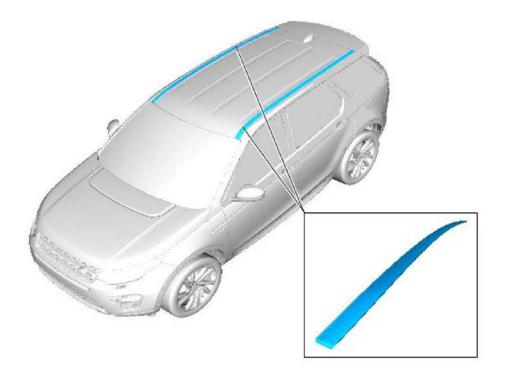
E185645

1 The illustration shows the component location.
