# TECHNICAL BULLETIN

LTB00869NAS1  
21 DEC 2015

### Door Interior Trim Bubbling/Delaminating

##### **Discovery Sport (LC)**

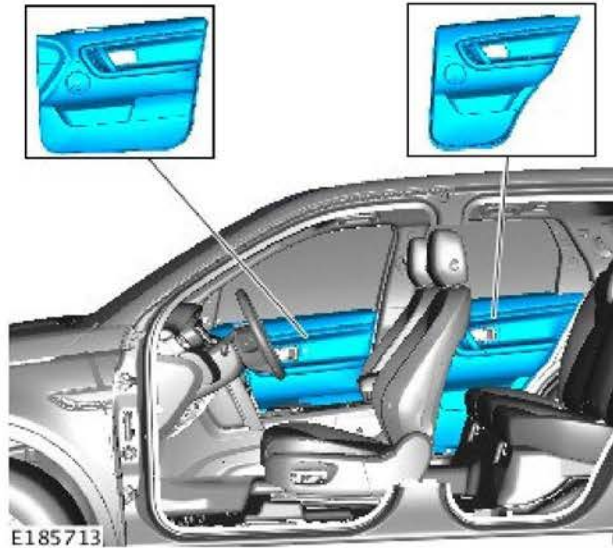
Component location.

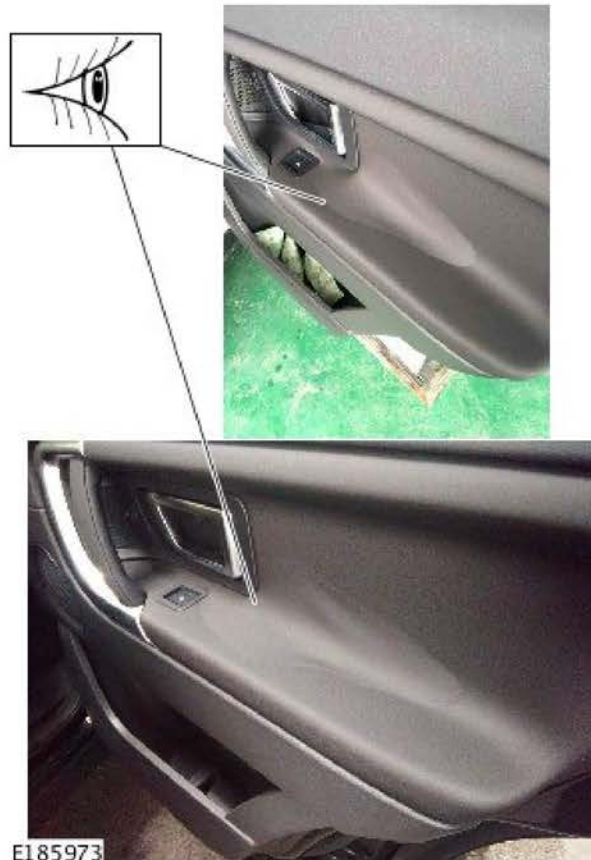
Inspect the door trim panels for any signs of bubbling or delamination.

**2** Replace ONLY the affected door interior trim panel(s) (see TOPIx Workshop Manual section 501-05: Interior Trim and Ornamentation).
