Reference	SSM68097
Models	Range Rover Evoque / L538
Title	L538 Front wheel bearing tone ring contamination
Category	Chassis
Last modified	07-Dec-2015 00:00:00
Symptom	304000 Suspension System
Attachments	11L538 tone ring contamination.jpg (11L538 tone ring contamination.jpg) 1Remove Debris1.pdf (1Remove Debris1.pdf)

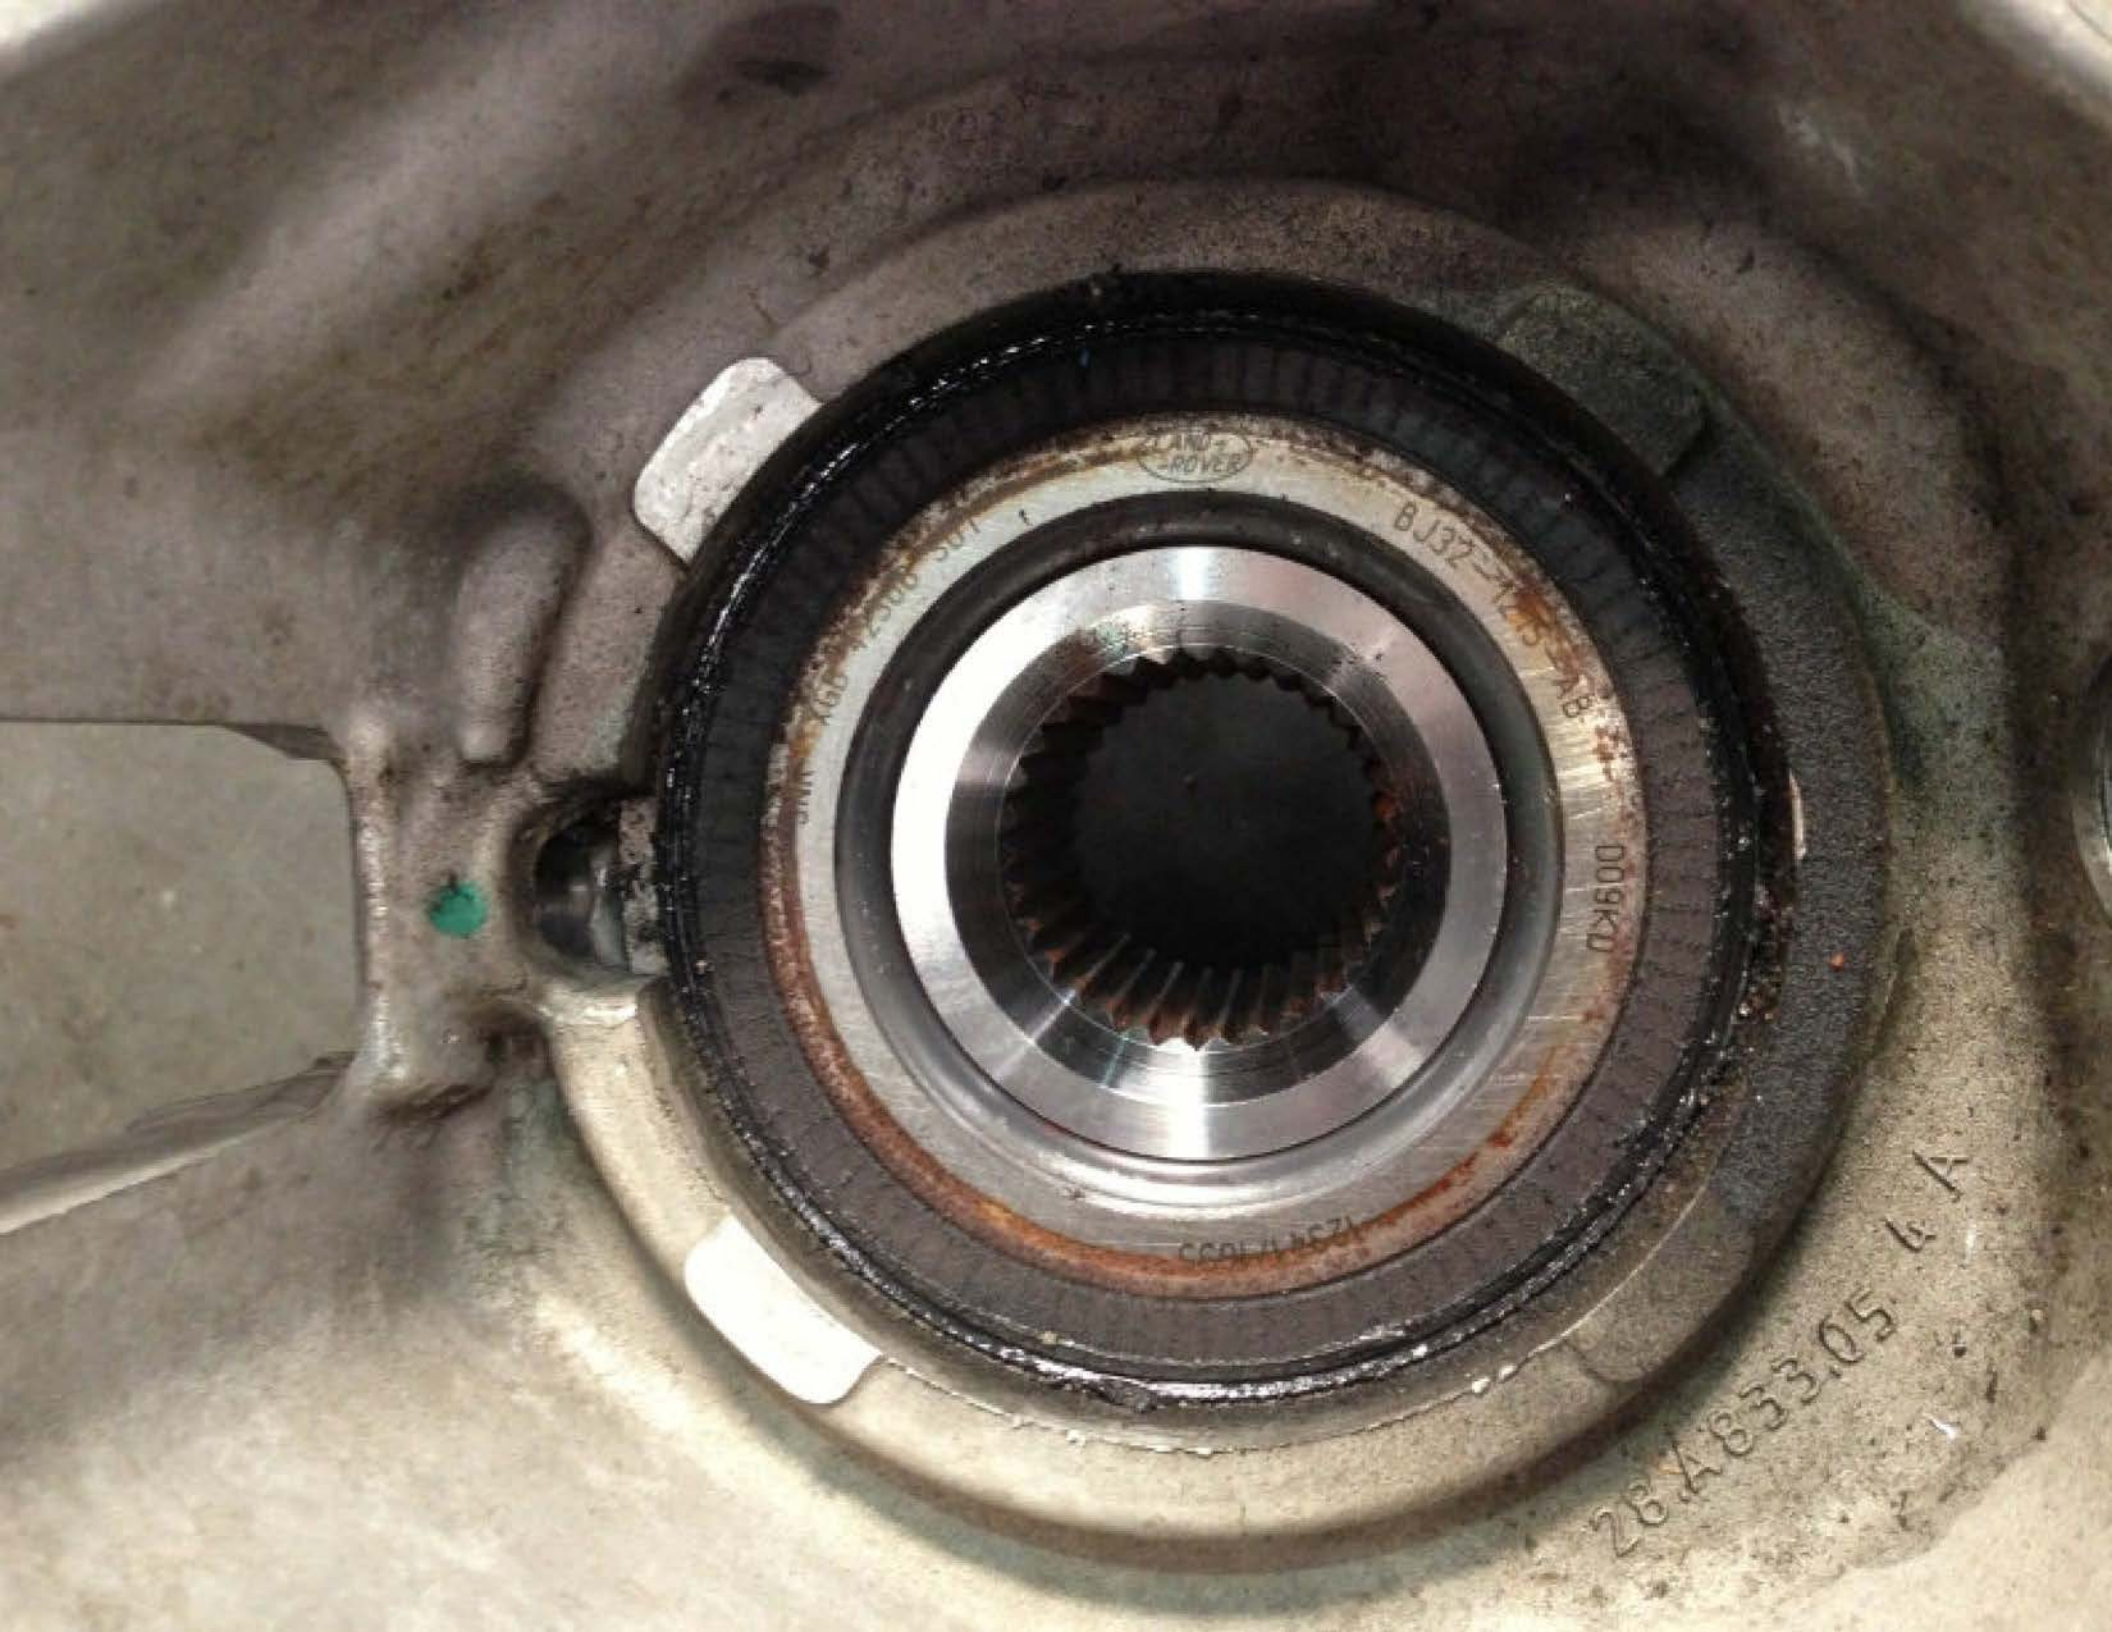
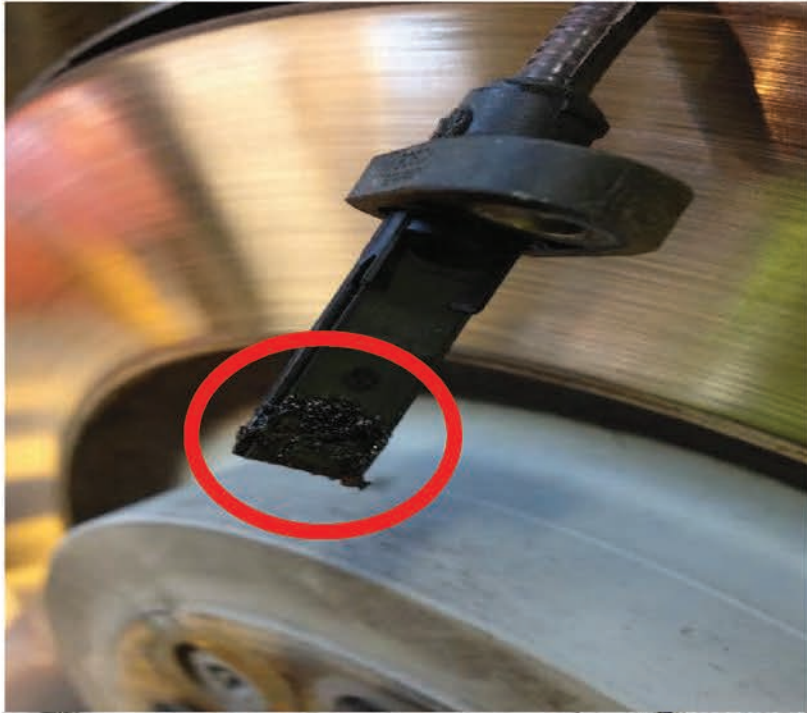
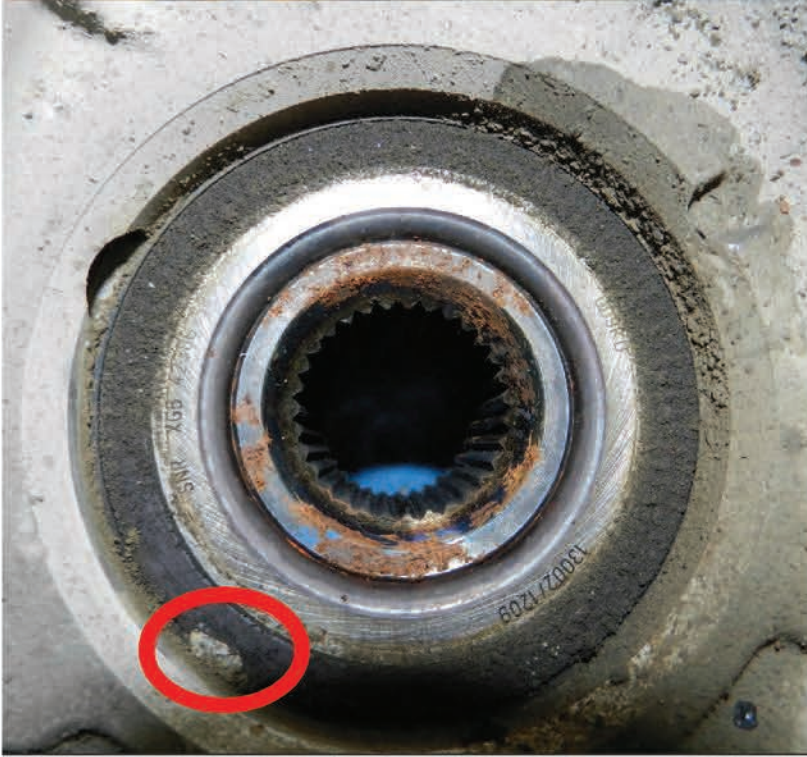
Dealers have reported cases where customers may report an Hill Descent Control or Slip Control System warning light showing on the instrument panel. Subsequently through correct diagnosis, dealers have identified contamination build up evident on the front wheel bearing tone rings . Examples are attached.

Root cause of the contamination is still being investigated. However, analysis of returned parts indicates that cleaning the tone rings and sensors can repair the vehicle to an acceptable condition without the need to replace the bearing and knuckle assembly

In such instances, dealers are requested to remove the wheel speed sensor and drive shaft and clean the area with a suitable, locally-sourced wipe. Inspect to ensure contamination has been removed.

Refit shaft and sensor, tightening to the specifications detailed in TOPIX (a new retaining nut for the shaft will be required). Carry out an extended road test to determine if the fault re-occurs.

Should the fault re-occur, replace bearing and/or knuckle assembly (new shaft retaining nut will be required).
