Reference	SSM72556
Models	LR4 / L319 Range Rover / L405 Range Rover Sport / L494
Title	16MY 3.0L S/C V6 & 5.0L S/C V8 Heated Oxygen Sensor (HO2S) - Post catalyst - Bank 1 (or Bank 2) sens
Category	Driveability
Last modified	18-Dec-2015 00:00:00
Symptom	698298 Malfunction Indicator Lamp
Attachments	Heated Oxygen Sensor (HO2S).pdf (Heated Oxygen Sensor (HO2S).pdf)

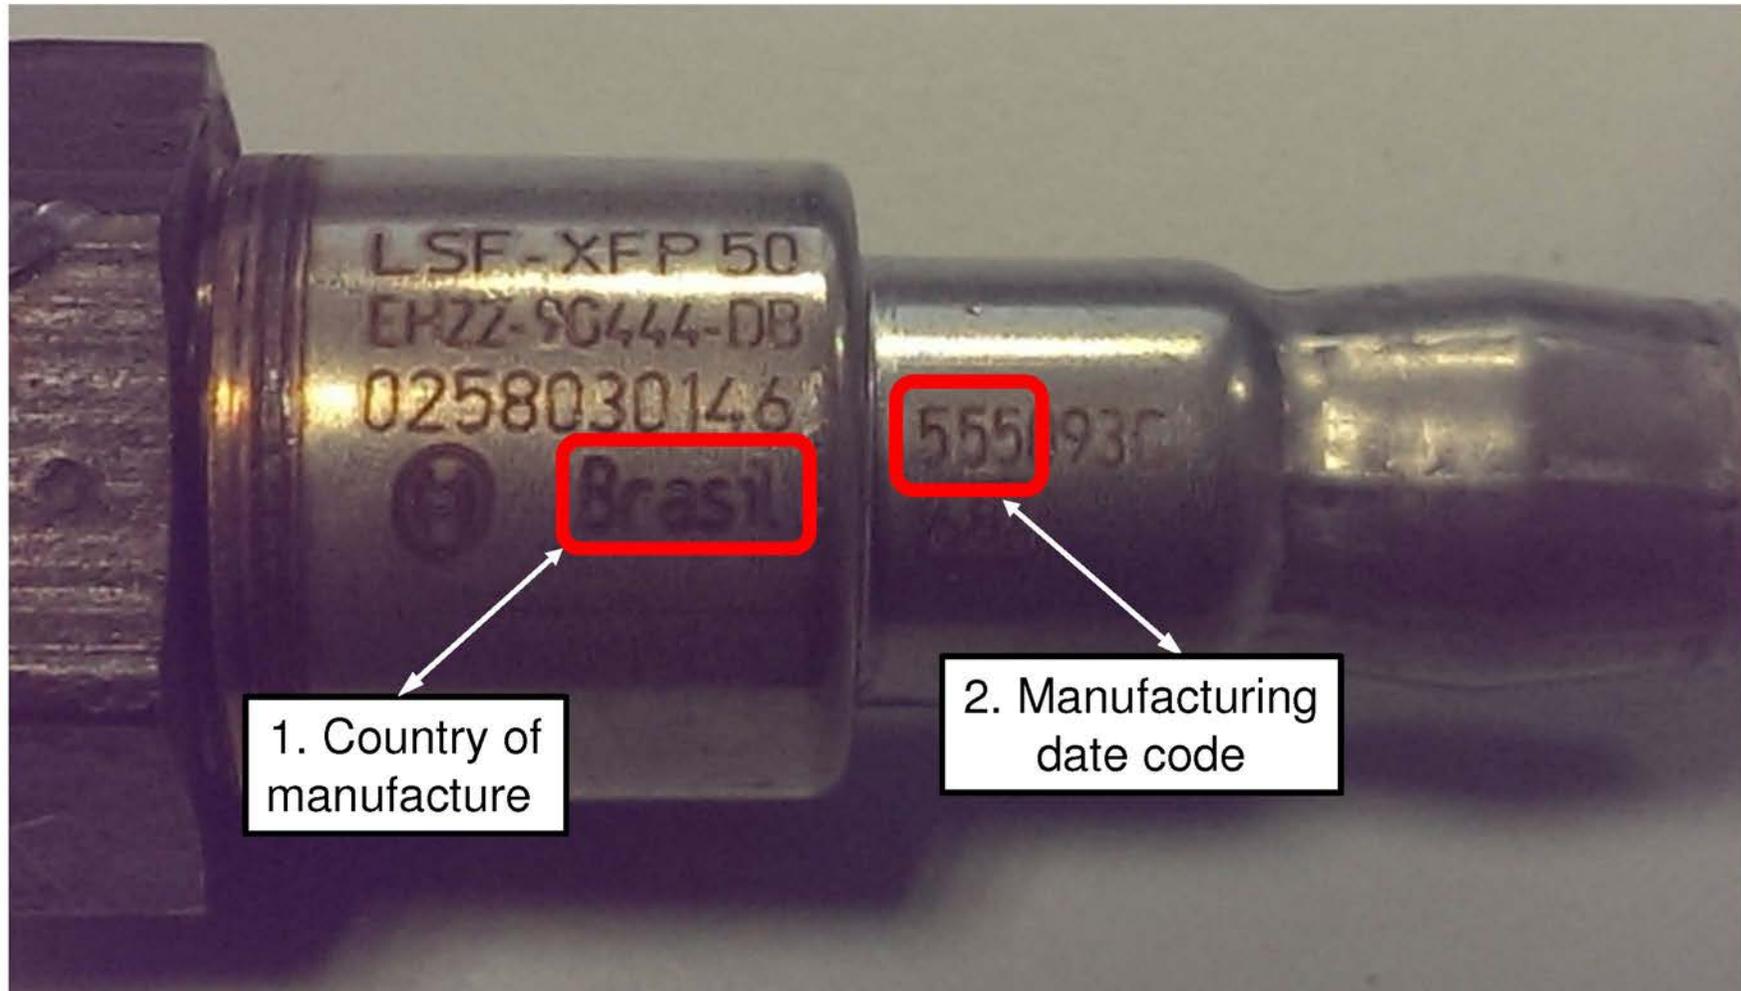
Refer to the attached file which shows location of the date code and country of manufacture on the sensor.

1. Look for country – **Brasil**
2. Look at the first three digits of the date code. If the code reads **554**, **555**, **556** or **557** the sensor must **NOT** be fitted to the vehicle.

- If the country of manufacture states 'Germany' the sensor is OK to fit.
- If the country of manufacture states 'Brasil' check the manufacturing date code on the sensor prior to fitment:
 - **If the code reads 554, 555, 556 or 557 the sensor must not be fitted to the vehicle!**
