August 25, 2015

51398-02259 Version 2

Function Buttons (PHONE, MENU, BACK, SETTINGS, Etc.) Stick

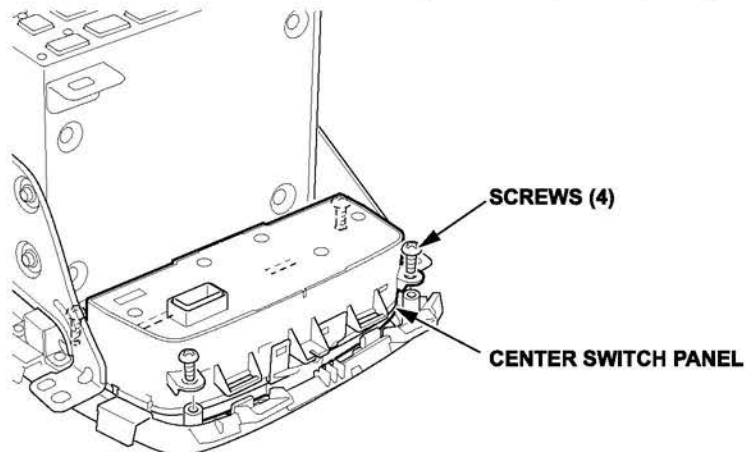
The center switch panel is deformed or is not centered in the audio unit panel.

1. Loosen the center switch panel screws, center the switch and retighten the screws. Make sure the switch is centered in the audio or audio-navigation unit panel opening and the buttons are no longer sticking.
