May 13, 2015

01621 Version 1

AcuraLink[®] System Status Indicator Is Red and DTC B1403 Will Not Clear

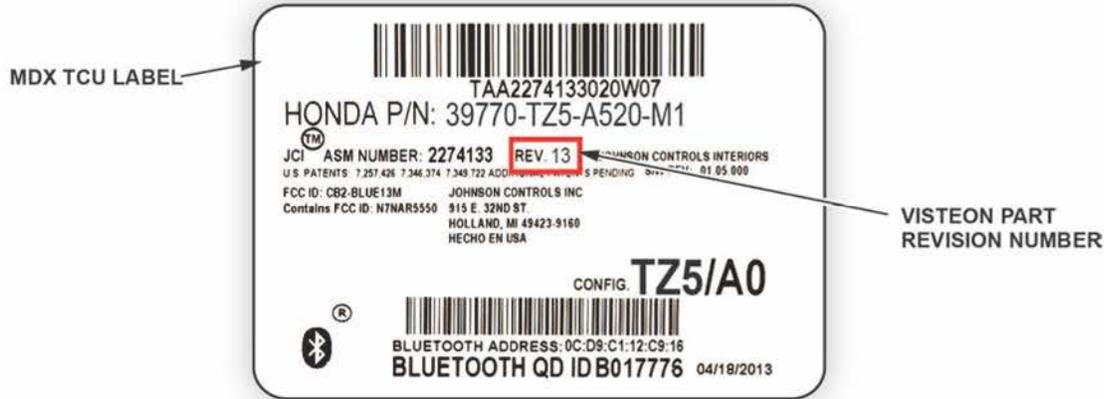
3. Check the label for the latest Visteon part revision number.
 - If the Visteon part revision number is 13 or above and the software revision number is 02.07.000 or above, the TCU is okay and this bulletin does not apply. Continue with normal troubleshooting.
 - If the Visteon part revision number is 12 or less and/or the software revision number is 02.06.000 or less, replace the TCU and go to step 4.

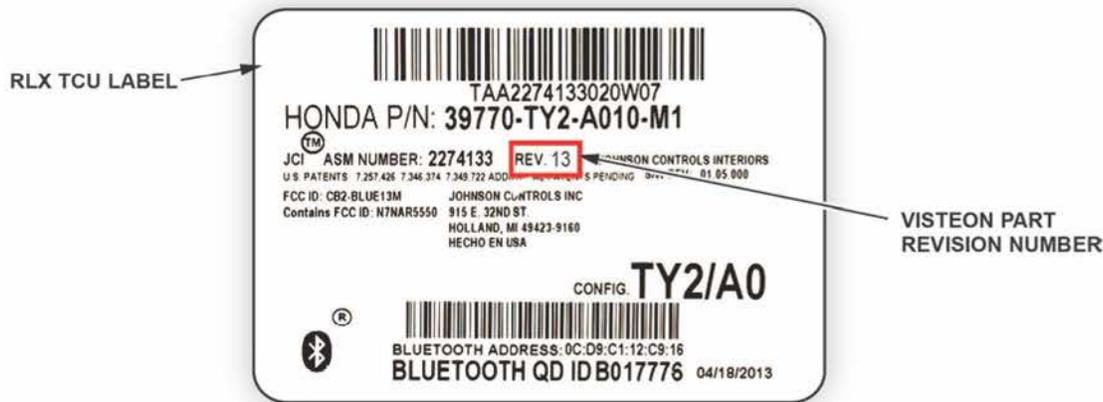
- Check the label for the latest Visteon part revision number.
 - If the Visteon part revision number is 13 or above and the software revision number is 02.07.000 or above, the TCU is okay and this bulletin does not apply. Continue with normal troubleshooting.
 - If the Visteon part revision number is 12 or less and/or the software revision number is 02.06.000 or less, replace the TCU and go to step 4.

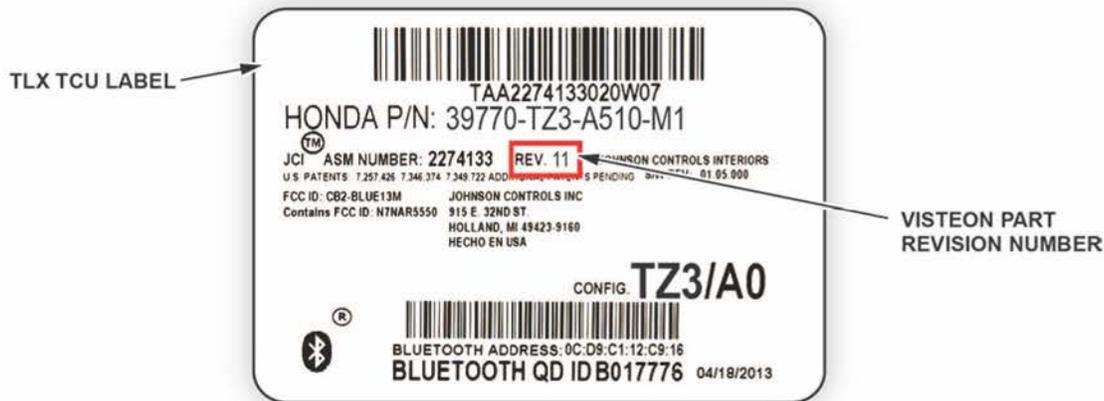
4. Check the label for the latest Visteon part revision number.
 - If the Visteon part revision number is 11 or above and the software revision level is 01.05.000 or above, the TCU is okay and this bulletin does not apply. Continue with normal troubleshooting.
 - If the Visteon part revision number is 10 or less and/or the software revision number is 01.04.000 or less, replace the TCU and go to step 5.
