May 5, 2015

01261-01904 Version 3

Safety Recall: Headlight LED Lens Film Delaminates

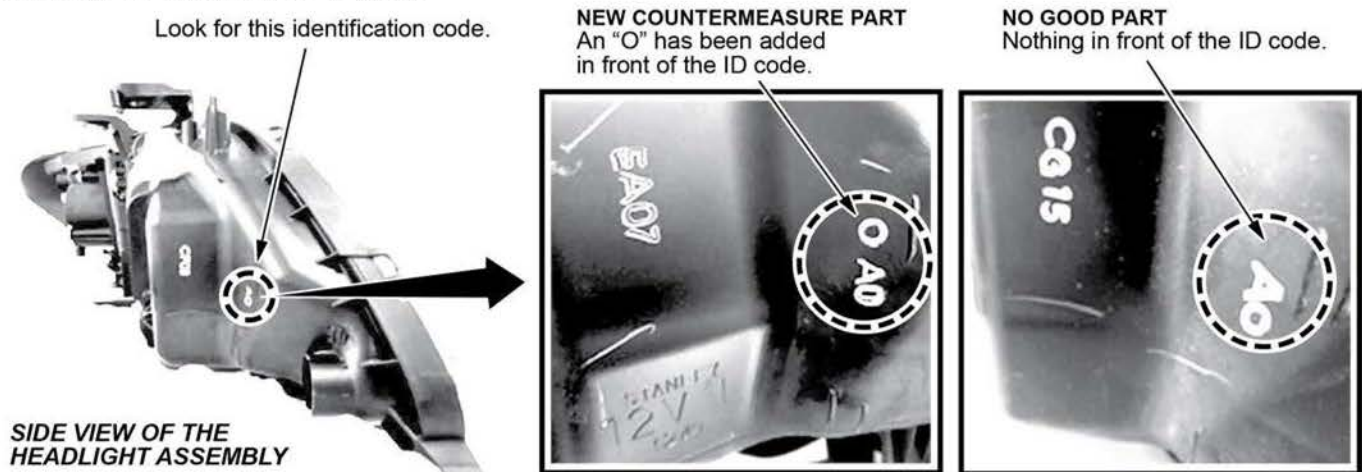
NOTE: To differentiate the original head light assemblies from the improved ones, the improved assemblies have the letter "O" in front of the ID code.

5. Install the new headlights onto the corner upper beam and tighten the bolts to **9.4 N·m (6.9 lb-ft)**.
