2014-2015 MAZDA3 WITHOUT MAZDA CONNECT PERSONALIZATION FEATURES

MULTI-MODEL HANDS-FREE CALL HAS POOR RECEPTION

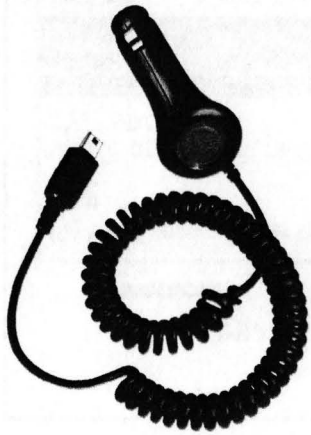
Accessory mobile phone charger

This condition may be caused by an aftermarket accessory mobile phone charger. The charger may be the source of the interference.

1. Remove the customer's accessory mobile phone charger(s) from the vehicle's power outlet(s).
2. If the problem is no longer present, do not perform any repairs. Advise the customer to purchase a different brand mobile phone charger.

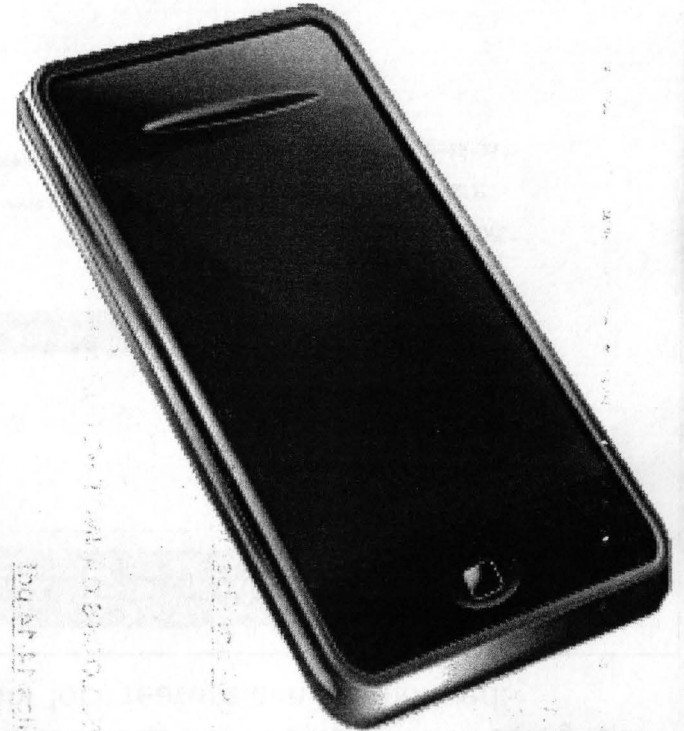
Hands-free phone

- Hands-free conversation from audio system has static.
- Receiver states that he/she hears static during the call.
