MULTI-MODEL BRAKE MASTER CYLINDER FLUID LEAK

2014-2015 Mazda3/Mazda6, 2013-2015 CX-5 A/C COMPRESSOR SERVICE CAUTION

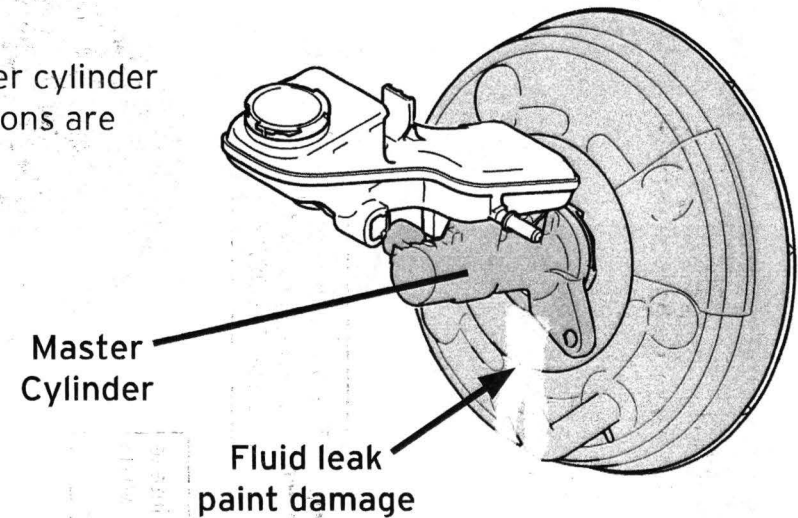
When performing brake system maintenance or repairs, check the brake fluid level before proceeding. Fluid level may have been topped off during a previous service visit. If the brake fluid level is at MAX and brake system maintenance or repairs are performed, fluid may spill on body painted surfaces and/or other components causing damage.

If the vehicle requires brake pad lining replacement and the brake master cylinder fluid level is at MAX or higher, fluid may spill when the brake caliper pistons are compressed.

If not cleaned, the following may occur:

- The brake system may be misdiagnosed at the next service visit (technician suspects a faulty brake master cylinder).
- Brake booster paint damage.
- Body surface paint damage.
- Electrical harness/component damage.

If fluid level is at MAX or higher, use a siphon to reduce the fluid level. This will prevent a fluid leak during maintenance or repair.

If brake fluid spills on painted surfaces, clean immediately.

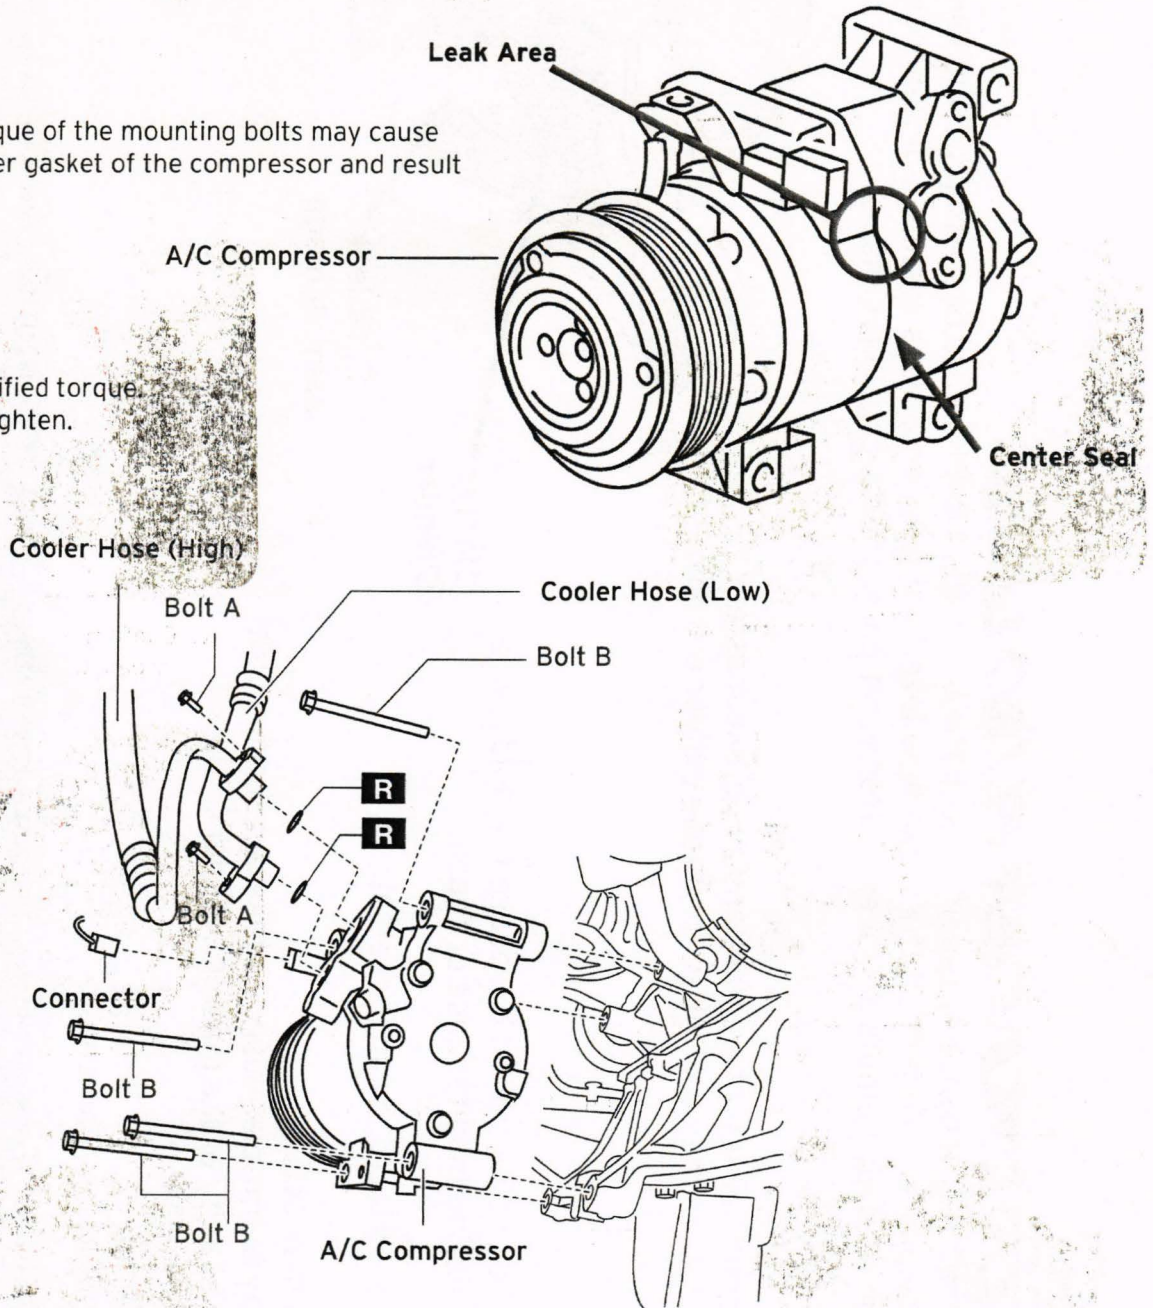
Improper tightening torque of the mounting bolts may cause poor sealing at the center gasket of the compressor and result in a refrigerant leak.

When replacing an A/C compressor, use the specified torque in the Workshop Manual "A/C COMPRESSOR REMOVAL / INSTALLATION".

Apply the specified torque.
Do NOT over tighten.

Specified torque

Bolt A: 8-10 Nm {82-101 kgf cm, 71-88 in lbf}

Bolt B: 19-25 Nm {2.0-2.5 kgf m, 15-18 ft lbf}
