Dealer Service Instructions for:

Customer Satisfaction Notification R65 Reprogram Radio Control Head

2014-2015 (JC) Dodge Journey

The radio navigation system on about 30,300 of the above vehicles may experience a condition which permanently renders the navigation features not functional as a result of memory corruption.

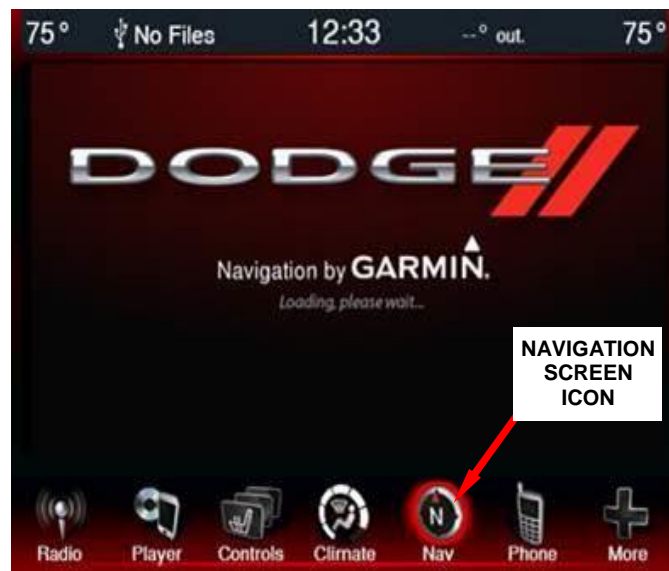
Figure 1 – System Loading Screen

1. Start the vehicle, turn the radio on and allow the radio to power up.
2. Press the navigation screen icon and attempt to access the navigation main menu system (Figure 1).
3. If the radio is stuck on the “Loading Please Wait” screen, proceed to **Section E. Radio Replacement**. If the navigation screen main menu appears, continue with **Section B. Download Software Files**.

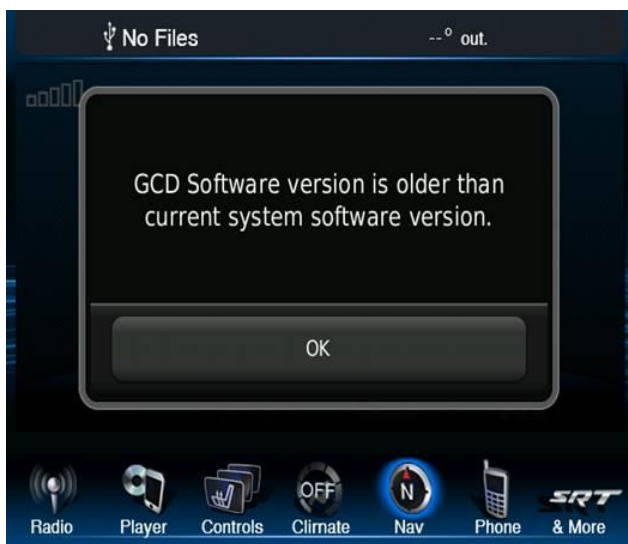
Figure 6 – Garmin Software Already Updated

7. Which screen does the radio currently display?
 - (Figure 6) >>> The radio has the latest Garmin software installed. Press OK and proceed to **Step #11**.
 - (Figure 7) >>> Press Yes to continue then proceed with the Garmin software update **Step #8**.
8. The first step in the update is “**system recover**”. There will be a pop up that indicates this step along with a progress bar. This step will take a few minutes.
9. This next screen will be displayed when the update is being loaded as shown in (Figure 8).
