## ROADSTER 2015 Product Reference Article - 108572

Up-to-date technical information on the 2015 Roadster product. Destined for dealer service department staff.  
This document may change without notice, always consult the latest version available.

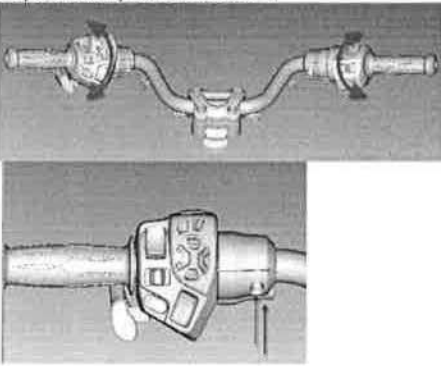
| 2015 | F3 | Handlebar commodo movement - clamp not torqued enough | No Case needed | On a few F3 units the handlebar commodo (multi-function switches) may rotate, this is due to the handlebar end clamp not being fully torqued. Simply torque the clamp bolts to 11 ± 1 Nm.<br> | | 11-02-2015 |
