## Connector Cavity Plugs VAH, VHD, VN

### SP 371-051, Connector Cavity Plugs

(January 2016)

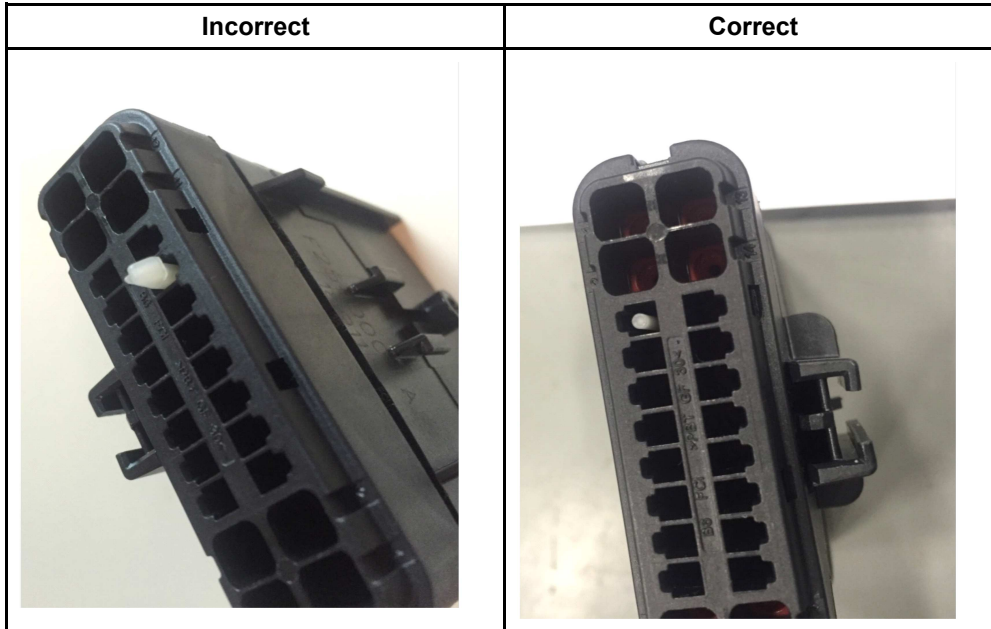
6 Inspect for backwards seals.

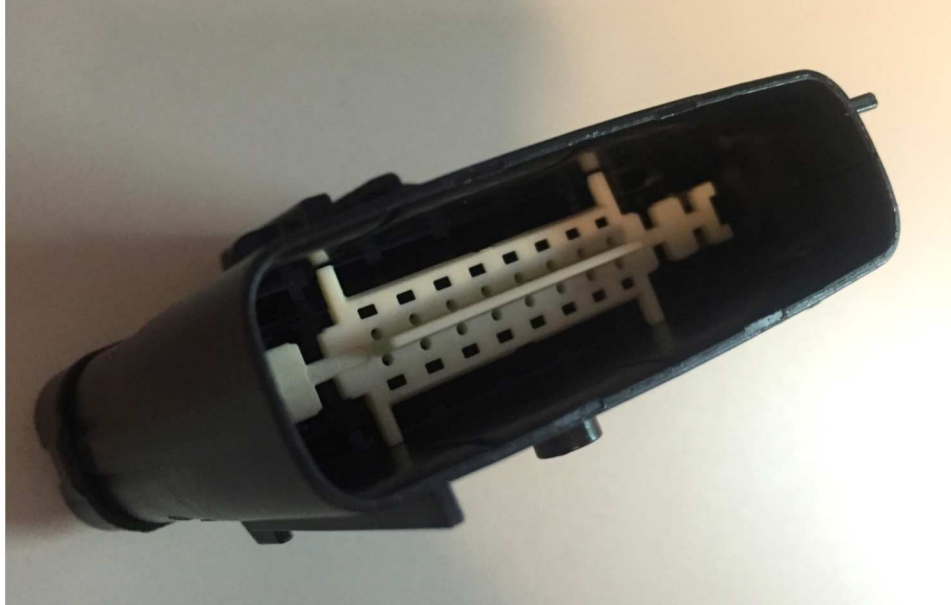
W3109251

7 Inspect for corrosion inside connectors.
