Subject: Freightliner Argosy and Coronado Axle Tower Brackets - Export Only

Models Affected: Specific Freightliner Argosy and Coronado vehicles manufactured January 1, 2010, through December 7, 2015, equipped with Neway AD 246 rear suspension and Meritor RT-52-185 tandem rear axle.

Daimler Trucks North America LLC, on behalf of its Freightliner Trucks Division, is initiating Field Service Campaign SF516A to modify the vehicles mentioned above.

January 2016
SF516A

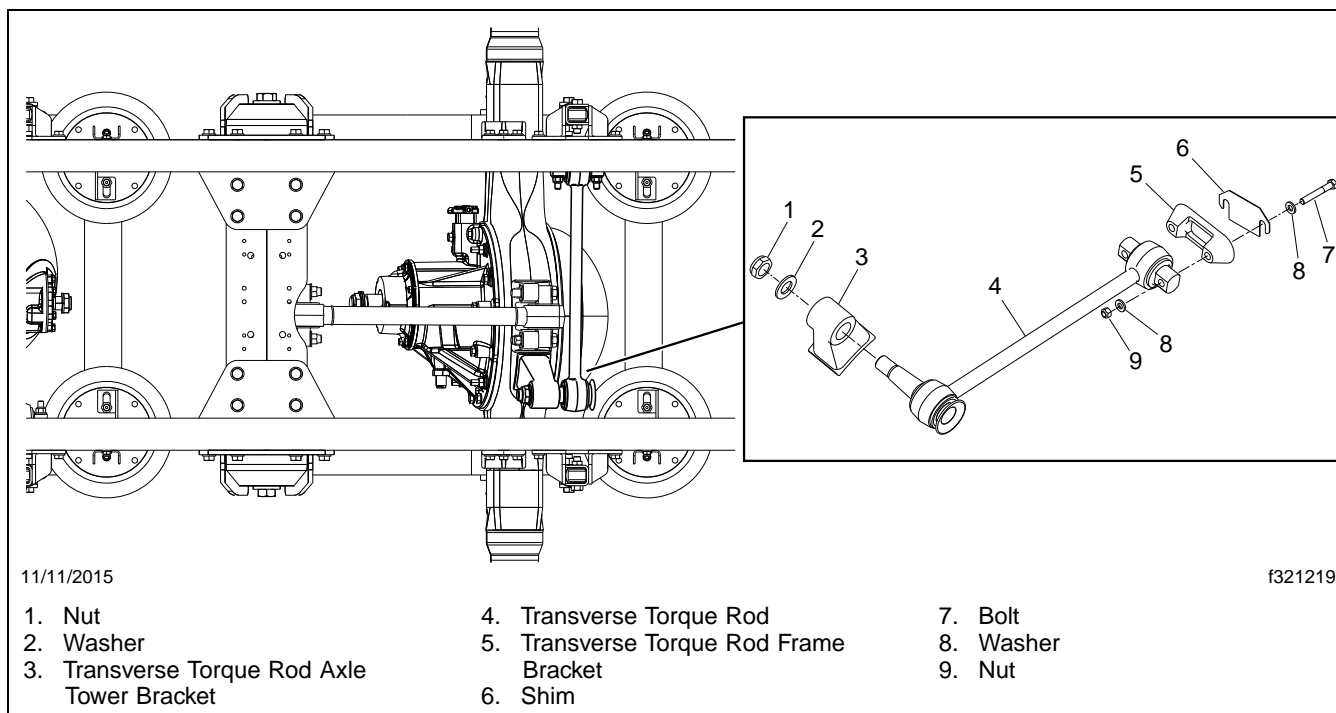
Fig. 1, Neway Suspension Rearmost Axle Assembly

Certain vehicles may have an incorrect transverse torque rod tower bracket installed on the rearmost drive axle. An incorrect axle tower bracket results in poor alignment of the transverse torque rod and premature failures of the transverse rod tapered pin and/or bushing.

5. Remove the three mounting fasteners from the transverse torque rod and discard the rod and fasteners. Save the shims. See **Fig. 1**.
