# 2016 MX-5, 2016 CX-3, and new 2016 CX-9 BLIND SPOT MONITORING (BSM) SYSTEM CHANGE

# MULTI-MODEL (EQUIPPED WITH MAZDA CONNECT) NAVIGATION AND/OR SIRIUS XM RADIO INOPERATIVE

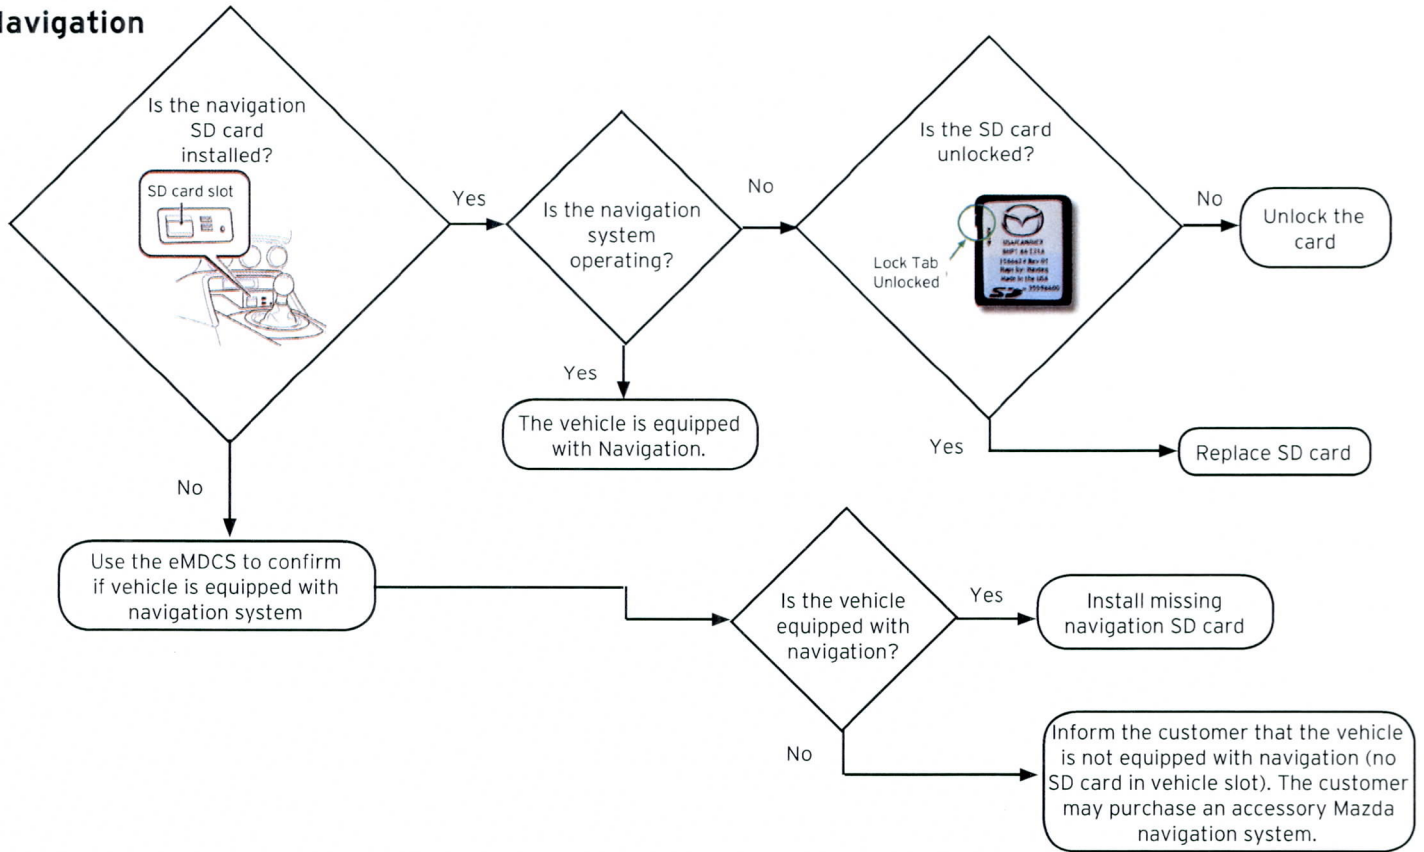
## Navigation

Most lower trim models equipped with the MAZDA CONNECT Infotainment System are NOT equipped with Navigation or SIRIUS XM Radio. Customers may add a Mazda Navigation system accessory; however, SIRIUS XM radio cannot be added.

Use the information below to determine if customer's vehicle is equipped with Navigation or SIRIUS XM Radio.

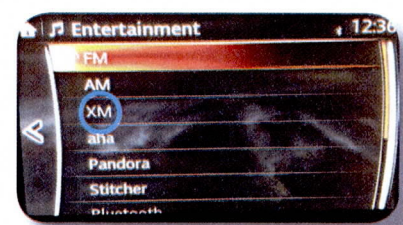
- If XM is selectable, the vehicle is equipped with SIRIUS XM Radio
- If XM is not selectable (grayed out), the vehicle is not equipped with SIRIUS XM Radio

- SIRIUS XM Radio cannot be added as an accessory.
- If vehicle is equipped with SIRIUS XM Radio, subscription is required.
- You can also use the eMDCS to confirm if vehicle is equipped with SIRIUS XM Radio.
