## VEHICLES EQUIPPED WITH SKYACTIV *MIL ON WITH DTC P0882:00*

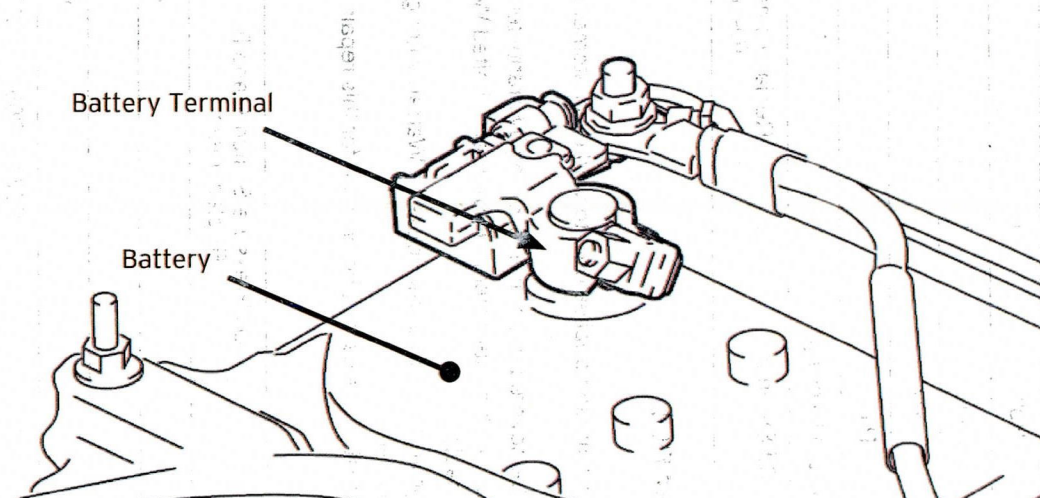
Some customers may complain about a MIL ON with DTC P0882:00 (TCM Power Supply Voltage Low). Loose battery terminals may be the cause.

Check battery terminals for looseness. If loose, torque battery terminals to specification, then erase DTC(s).

**Battery Terminal Torque:** 36-53 in-lbf (22-30 Nm)
