2014-2016 Mazda3

MAZDA CONNECT "NO SIGNAL" MESSAGE IN REVERSE

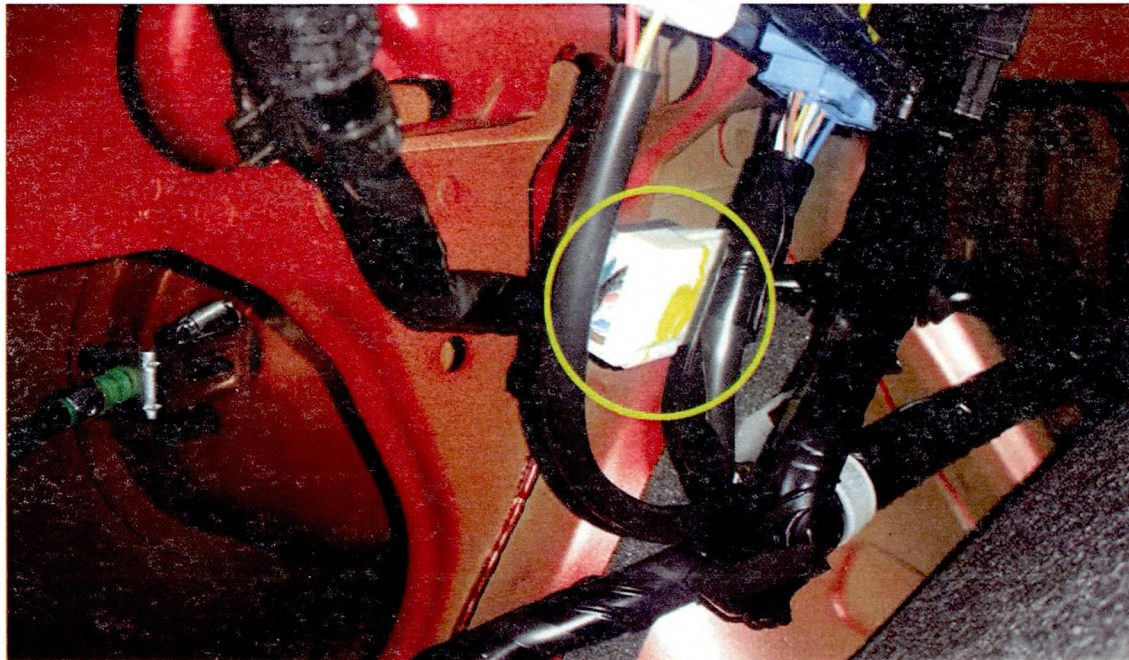
Some customers may complain about the rear view monitor showing a "NO SIGNAL" message in Reverse. A poor electrical connection at connector C-16 may be the cause.

A simple disconnect and reconnect of connector C-16 may resolve the customer's concern. Connector C-16 is located at the left side of the trunk (sedan) or cargo area (hatchback). C-16 trunk connector (sedan) is shown.
