# Service Bulletin

Bulletin No.: 16-NA-042

**Subject:** Infotainment System Upgrade for Android Auto Feature

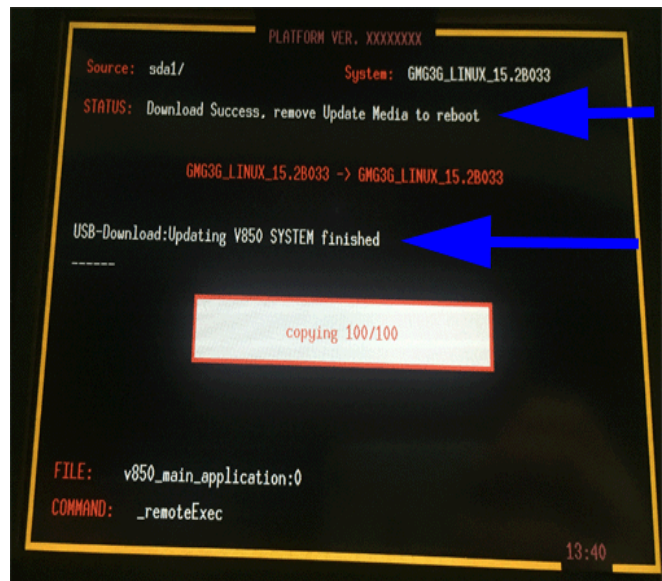
4448895

**Important:** Once the updating file hits 90% the screen may go blank. DO NOT REMOVE the USB at this time. The illustration above shows when the programming is complete. (See blue arrows above.)
