Service Bulletin

Subject: Foam And Cardboard Insert Found In Trunk During PDI

Models: 2016-2017 Chevrolet Volt

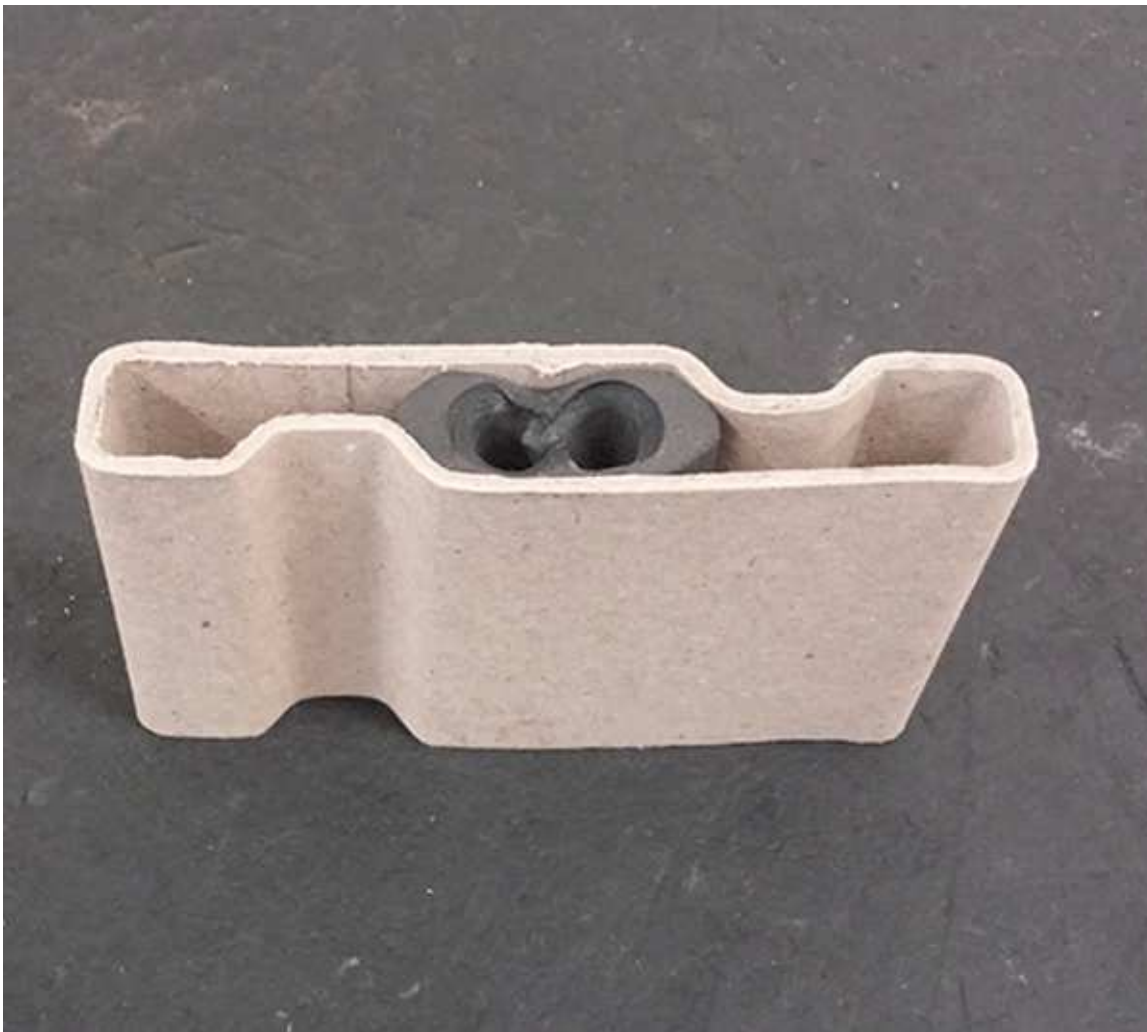
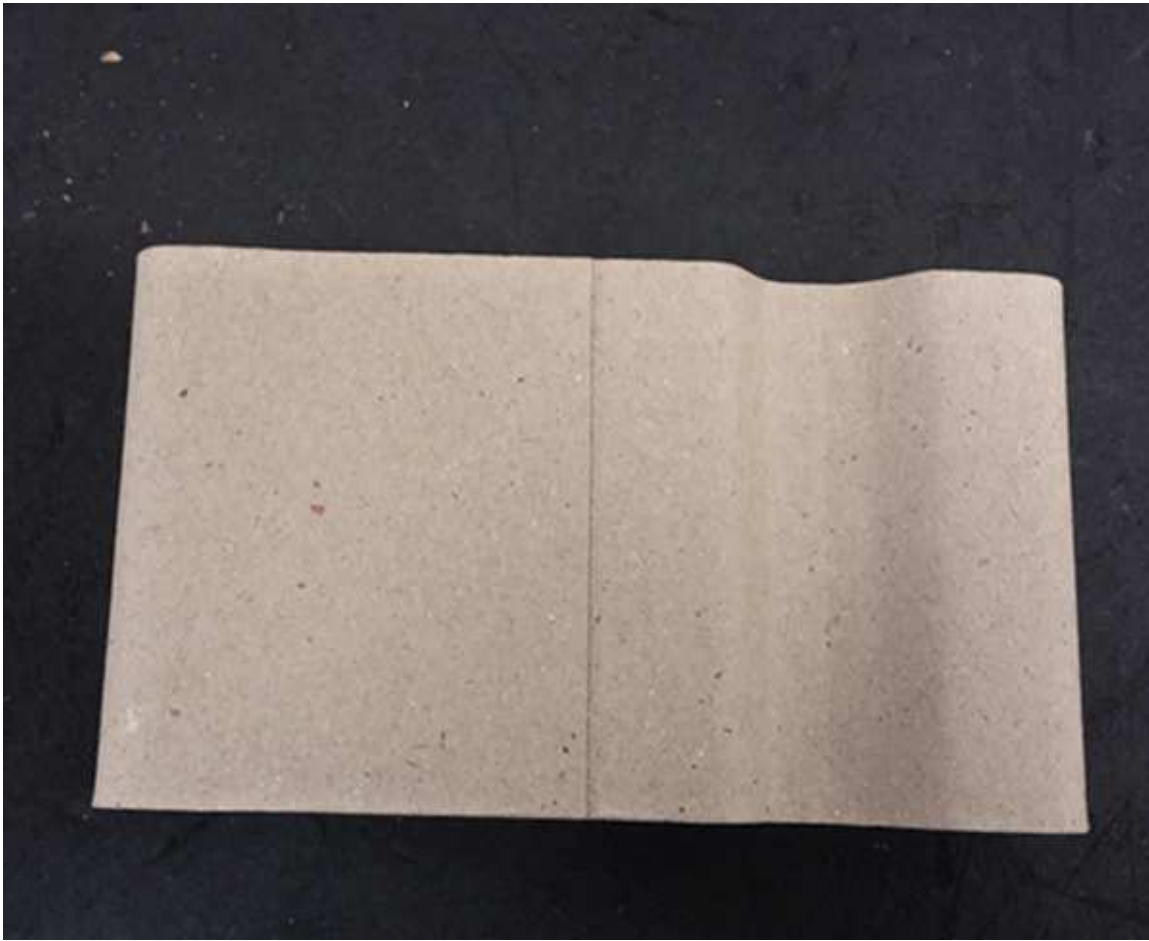
When performing a pre-delivery inspection you may find a piece of foam that is surrounded by a cardboard shell that is found in the vehicle during PDI. (See Photos below)

This Insert is a spacer that is part of the tire Inflator kit and should be placed between the compressor assembly and the tire sealant canister. This Insert needs to be installed to prevent the damage to the contents of the bag when tightening the hold down for the Inflator kit.
