# Program Bulletin

## CUSTOMER SATISFACTION PROGRAM

**SUBJECT:** Oil Pickup Tube Bolt Retention

**MODELS:** 2016 Cadillac CTS-V Equipped with 6.2L V-8 (RPO LT4)  
2016 Chevrolet Camaro SS Equipped with 6.2L V-8 (RPO LT1)

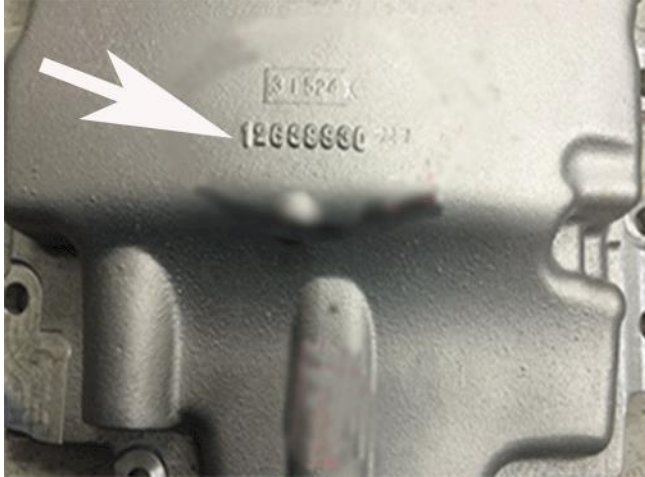
4484708

Use the following steps to inspect the identification number on the front of the oil pan. All oil pans will have markings in this area, some are engraved and some are raised. Only vehicles with the raised cast in numbers require repair. If the oil pan has the raised casting numbers, it will be necessary to service or replace the oil pan.

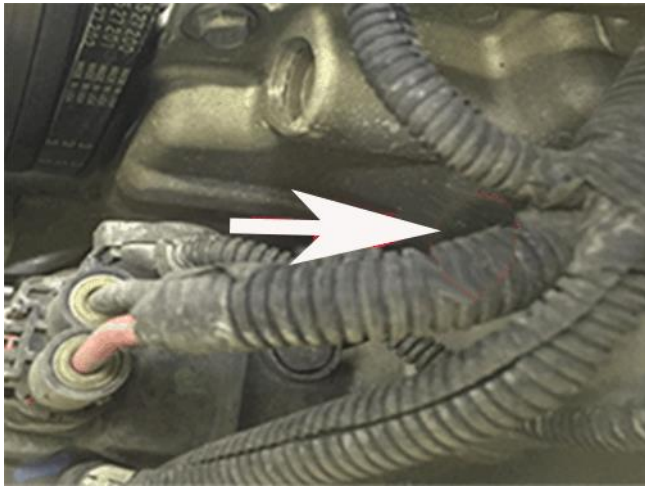
4484710

2. Using a flashlight and a mirror, inspect the identification markings on the front area of the oil pan. It may be necessary to move the wiring harness to see the number.
  - If the pan has raised marking in this location the pan will need to be repaired or replaced. Proceed to the repair procedure.
  - If the raised markings are not present no further action is required.
