Bulletin No.: 14284A
Date: April 2016

Program Bulletin

CUSTOMER SATISFACTION PROGRAM

SUBJECT: Upfitter Auxiliary Switches
MODELS: 2014 Chevrolet Silverado 1500
2015 Chevrolet Silverado
2014 GMC Sierra 1500
2015 GMC Sierra
Equipped with Auxiliary Switch Bank (RPO 9L7)

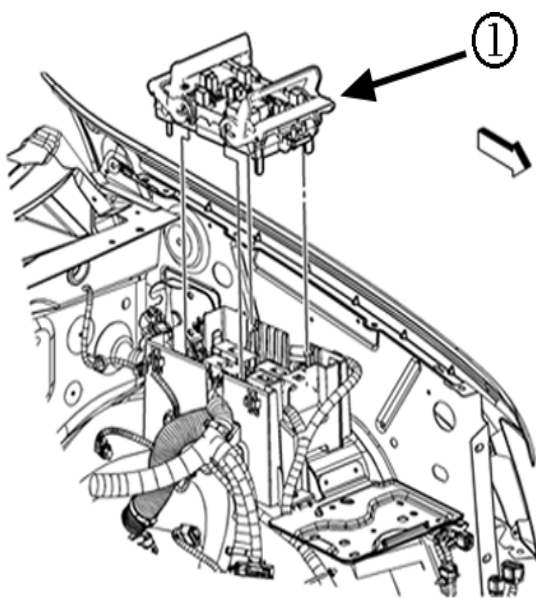
3963531

Certain 2014 and 2015 model year Chevrolet Silverado and GMC Sierra vehicles equipped with the Auxiliary Switch Bank (RPO 9L7) may have an electrical issue created when one or both Upfitter fuses used for the instrument panel mounted auxiliary switch bank are moved from the battery feed to the ignition feed position. If the fuse positions are altered, the engine could continue to run after the ignition switch is turned off. There could also be an inadvertent glowing of the auxiliary switch indicators, additional parasitic current drain, or a no start condition.

1. Remove the underhood electrical center (1). Refer to *Underhood Electrical Center or Junction Block Replacement* in SI.
2. Install the new underhood electrical center. Refer to *Underhood Electrical Center or Junction Block Replacement* in SI.
