Service Bulletin

SUBJECT: Service Update for Inventory Vehicles Only
Transmission to Engine Bolt Torque
Expires April 30, 2017

MODELS: 2016 Chevrolet Silverado
2016 GMC Sierra

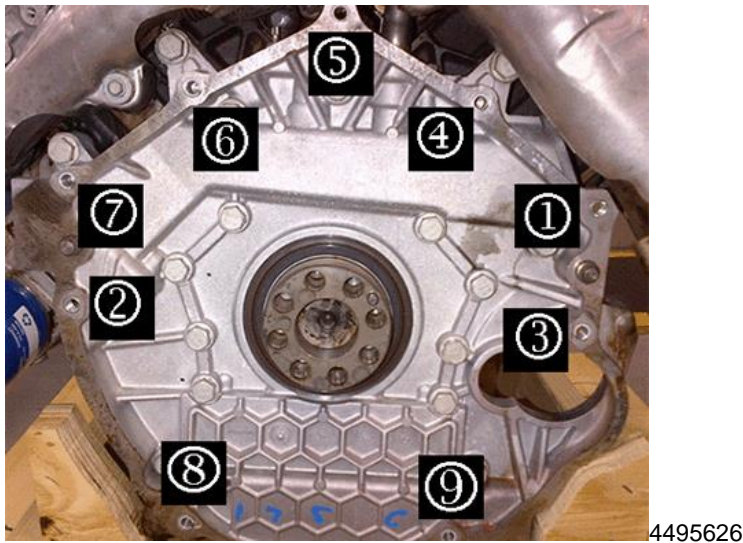
Illustration depicts a diesel engine. The gasoline engine does not have a bolt at position 4.

Note: Position 4 does not apply to gasoline engine.

8. Loosen the transmission bolts in the sequence shown.

9. Tighten the transmission bolts 1 and 2 to 50 Nm (37 lb. ft.). Starting with position 1 again, tighten bolts in sequence 1-9 as shown to 50 Nm (37 lb. ft.).
10. Install the fuel line bracket nut on the back of the transmission at the engine and reposition the fuel line bracket.
11. Raise the transmission back into place.
12. Install the three-way catalytic converter. Refer to *Three-Way Catalytic Converter Replacement* in SI.
13. Install the front axle propeller shaft, if equipped. Refer to *Front Axle Propeller Shaft Replacement* in SI.
14. Install the transmission support crossmember. Refer to *Transmission Support Crossmember Replacement* in SI.
15. Install the rear propeller shaft. Refer to *Rear Propeller Shaft Replacement* in SI.
16. Lower the vehicle. Refer to *Lifting and Jacking the Vehicle* in SI.

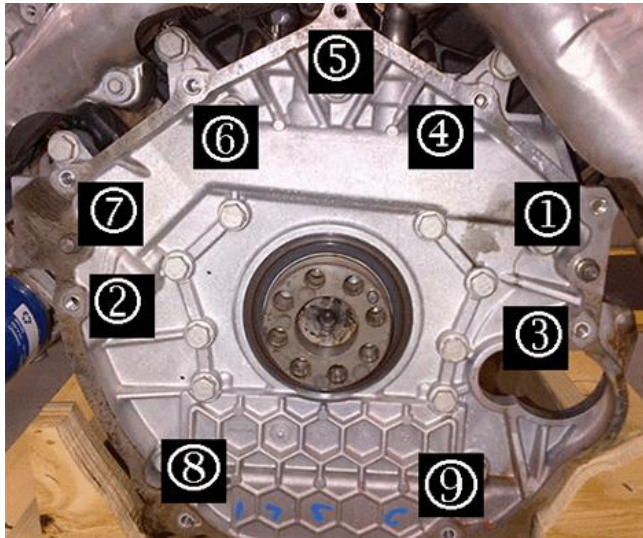
4495626

Illustration depicts a diesel engine. The gasoline engine does not have a bolt at position 4.

Note: Position 4 does not apply to gasoline engine.

5. Loosen the transmission bolts in the sequence shown.

- 6. Tighten the transmission bolts 1 and 2 to 50 Nm (37 lb. ft.). Starting with position 1 again, tighten bolts in sequence 1-9 as shown to 50 Nm (37 lb. ft.).
- 7. Reposition the wire harness/vent tube bracket and install the wire harness/vent tube bracket nut.
- 8. Raise the transmission back into place.
- 9. Install the transmission support crossmember. Refer to *Transmission Support Crossmember Replacement* in SI.
- 10. Lower the vehicle. Refer to *Lifting and Jacking the Vehicle* in SI.
