**3.7L - ILLUMINATED MALFUNCTION INDICATOR LAMP (MIL) -  
DIAGNOSTIC TROUBLE CODE (DTC) P013C - BUILT ON OR BEFORE  
4/21/2016**

**TSB 16-0078**

**LINCOLN:**  
2016 MKX

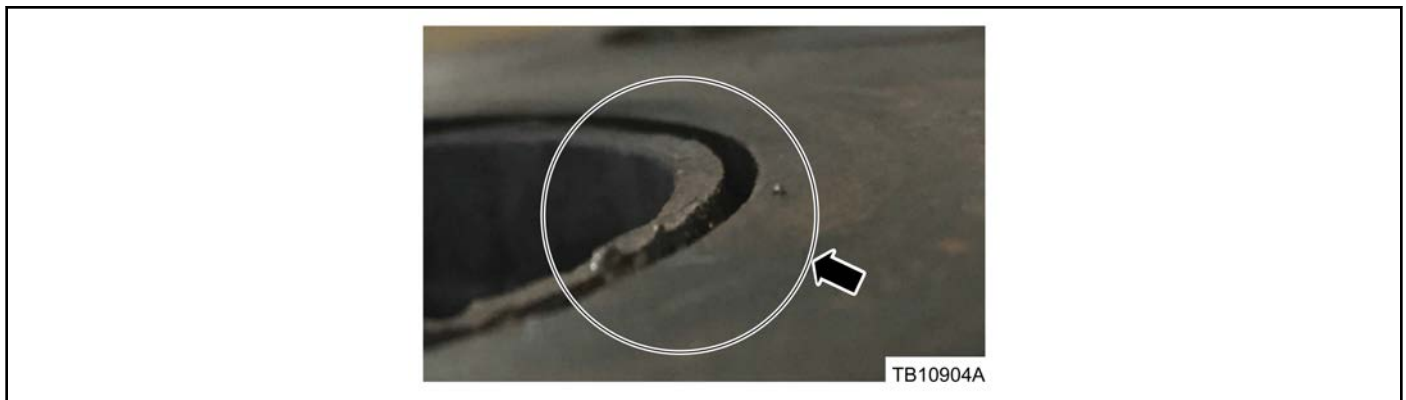
Figure 1 - Article 16-0078

Some 2016 MKX vehicles equipped with a 3.7L Duratec engine and built on or before 4/21/2016 may exhibit an illuminated MIL with DTC P013C stored in the powertrain control module (PCM). This may be caused by improper sealing of the left side exhaust y-pipe flange due to weld splatter or exhaust pipe intrusion into the flange sealing surface.

1. Use the Ford Integrated Diagnostic System (IDS) or equivalent scan tool to check for DTCs in the PCM. Is DTC P013C present?
  - a. Yes - proceed to Step 2.
  - b. No - this article does not apply. Refer to the Powertrain Controls and Emissions Diagnostics (PC/ED) manual for normal diagnostics.
2. Remove the exhaust y-pipe. Refer to Workshop Manual (WSM), Section 309-00.
3. Inspect the left side exhaust y-pipe flange sealing area that attaches to the left side catalytic converter for signs of weld slag and/or exhaust pipe intrusion into the flange sealing area. Are sign of weld slag and/or exhaust pipe intrusion present in the flange sealing area? (Figures 1-2)

- a. Yes - proceed to Step 4.
  - b. No - proceed to Step 5.
4. Use a flat file or 60 grit sandpaper on an oscillating sander with a flat pad to remove the weld slag and/or exhaust pipe material protruding above the flange sealing surface.
    - a. Removing too much material from the flange sealing surface may cause additional exhaust leaks.
  5. Check for proper torque of the left side catalyst monitoring sensor (CMS). The CMS should be torqued to 48 Nm (35 lb-ft).
  6. Clean the exhaust y-pipe mounting flanges with a clean microfiber cloth and replace the exhaust y-pipe gaskets.
  7. Reinstall the exhaust y-pipe. Refer to WSM, Section 309-00.
  8. Clear DTCs from the PCM memory.
