LINCOLN:
2016 MKX

Some 2016 Lincoln MKX vehicles built on or before 3/21/2016 may exhibit wind noise at the driver and/or passenger A-pillar to windshield area. The noise is most noticeable at highway speeds. This may be due to the windshield A-pillar moulding not being properly adhered to the A-pillar sheet metal and/or from the shape of the channel that runs inside the windshield moulding.

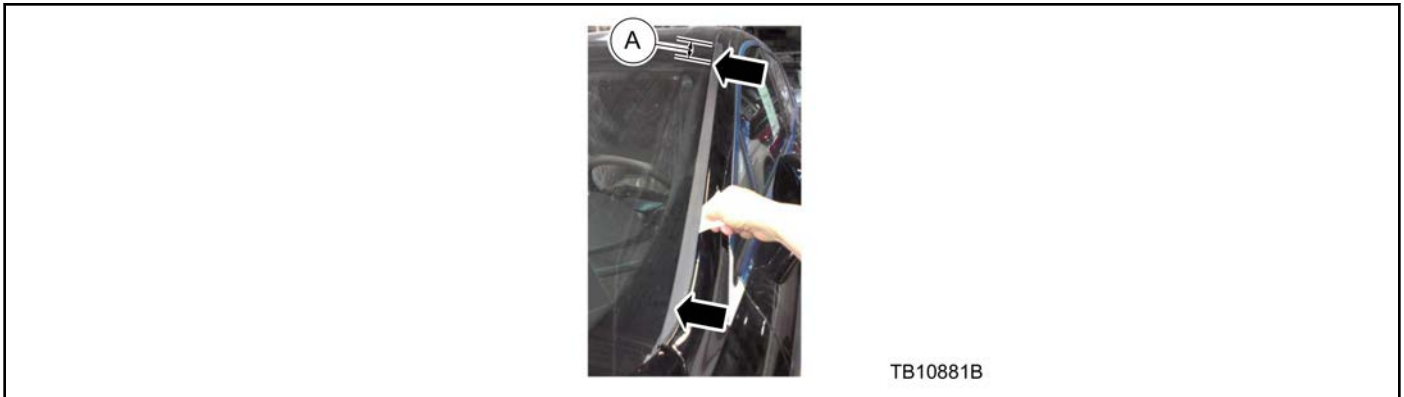
Figure 1 - Article 16-0088

1. Apply masking tape to cover the edge of the windshield and A-pillar moulding. Road test the vehicle. Does the vehicle exhibit wind noise from the windshield A-pillar?
 - a. Yes - this article does not apply. Refer to Workshop Manual (WSM), Section 100-04 for normal diagnostics.
 - b. No - proceed to Step 2.
2. On the back of a regular business card, measure 10 mm (13/32") from the short edge and draw a line.
3. On the passenger and driver side of the vehicle, measure approximately 25 mm (1") dimension A, and insert the business card between the windshield moulding and the metal A-pillar at the three points. At any point, can the business card be inserted more than 10 mm (13/32")? (Figure 1)

- a. Yes - proceed to Step 4.
 - b. No - proceed to Step 5.
4. Replace the windshield. Refer to WSM, Section 501-11.
5. Test fit the right stuffer on the passenger side of the vehicle.
