GROUP Transmission	MODEL 2016MY Sedona (YP)
	NUMBER PS441	DATE February 2016

SUBJECT: HARSH UPSHIFT AFTER PERFORMING TSB TRA 058 / SA208

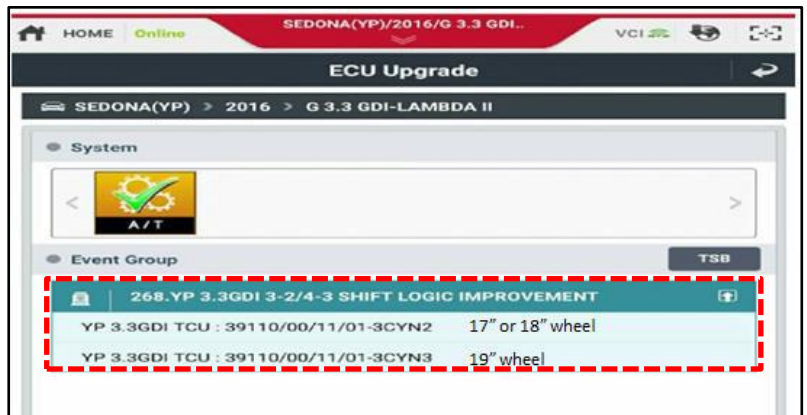
KMA has recently identified an increase in Techline cases with a complaint related to “A/T upshifting hard” in most gears. Further investigation has revealed that most of these occurred after performing TSB TRA 058 / SA208 using **Manual Mode** and possibly having, inadvertently, entered an incorrect PCM/TCM part number. In some cases, transaxles have already been replaced without condition improvement. Prior to replacing a transaxle for a similar customer concern, check current ROM ID number using GDS/KDS. NOTE: pay close attention to the wheel size reference information associated with PCM/TCM Part numbers.

If the ROM ID is not correct, reference the ROM ID information table (see below), the PCM/TCM can be corrected by performing another **Manual Mode** reflash. However, please ensure the correct PCM/TCM part number is selected to prevent any further drivability concerns and verify that the correct ROM ID is loaded after the reflash has been completed.
