GROUP BOD	MODEL 2013MY Optima (QF)
	NUMBER 128	DATE January 2016
TECHNICAL SERVICE BULLETIN		
SUBJECT: FUEL DOOR ACTUATOR REPLACEMENT (SA 217)

SUBJECT: FUEL DOOR ACTUATOR REPLACEMENT (SA 217)

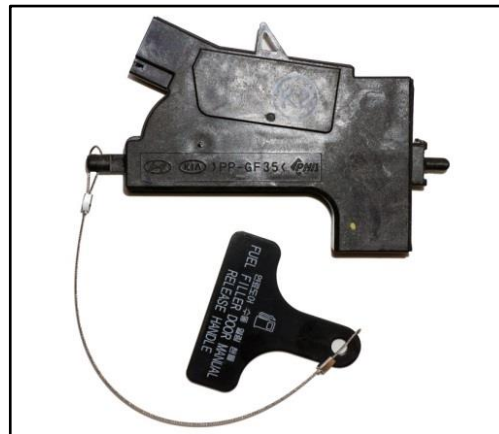
This bulletin describes the procedure to replace the fuel door actuator of some 2013MY Optima (QF) vehicles, produced from February 1, 2013 ~ March 14, 2013, which may exhibit an inoperable fuel door actuator. Follow the procedure outlined below to replace the fuel door actuator with an improved part and resolve the concern. Kia is requesting the completion of this Service Action on all affected vehicles. Before conducting the procedure, verify the vehicle is included in the list of affected VINs.
