MODEL
Multiple Models
(see table on Pg. 6)

NUMBER
077 (REV 1, 01/29/2016)

TECHNICAL SERVICE BULLETIN

SUBJECT: REAR VIEW CAMERA DIAGNOSIS/REPLACEMENT

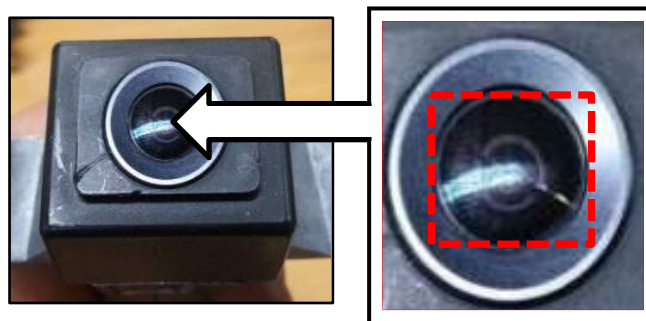
SUBJECT: REAR VIEW CAMERA DIAGNOSIS/REPLACEMENT**Camera Lens Inspection:**

1. Inspect the rear view camera lens for signs of damage due to impact from foreign object. If damage consistent with an impact is found, no further diagnosis is required.

Lens damage due to impact is not considered a warrantable repair.

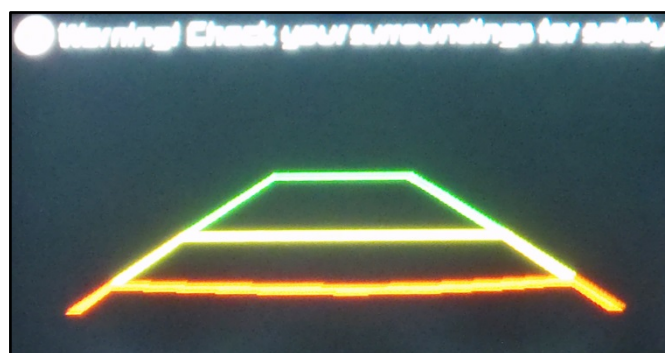
**Intermittent Operation:**

1. For customer complaints related to intermittent operation from the rear view camera, perform the following checks:
 - Confirm the parking guidelines are displayed on the AVN screen. If the guidelines are present and the vehicle owner resides in an area with high humidity, snow or rain, replace the rear view camera with an improved part.

For concerns related to intermittent operation, always try to duplicate the customer concern, prior to replacing the rear view camera.

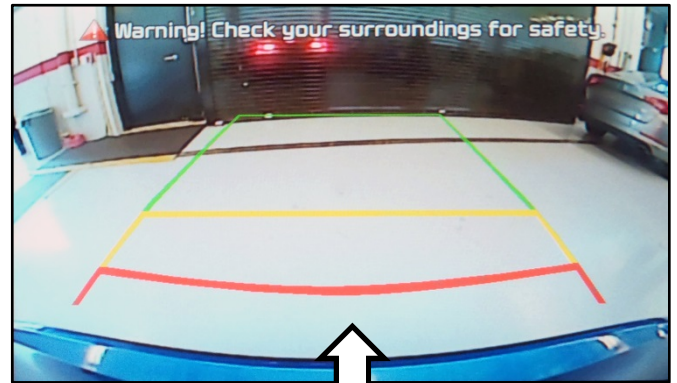
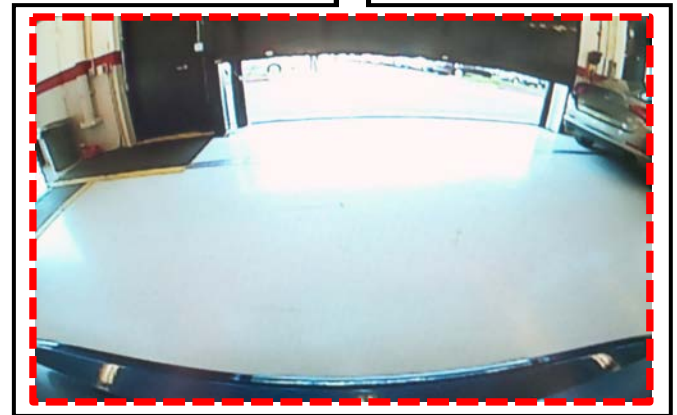
Missing Parking Guide Lines/Black or Blank AVN Screen:

1. If the AVN screen is missing the Parking Guide Lines or displays a black or blank screen, check the AVN system for proper operation:

Missing parking guide lines or a black/blank AVN screen are conditions indicative of an AVN system malfunction, or harness issue related to that system, and not a rear view camera module concern.

2. If the AVN system is functioning properly, perform the following checks:
 - Check the rear view camera wiring harness for pinched or damaged wires.
 - Place the transmission in reverse and confirm the AVN screen switches to rear view mode. If not, check for 12V signal at head unit.
 - If no 12V signal is found at head unit, check the transmission range switch circuit.
