MODEL  
**2011~2014MY  
Optima (TF/QF)**

NUMBER  
**060**

## TECHNICAL SERVICE BULLETIN

**SUBJECT:** ECM UPGRADE – STEERING LOGIC IMPROVEMENT

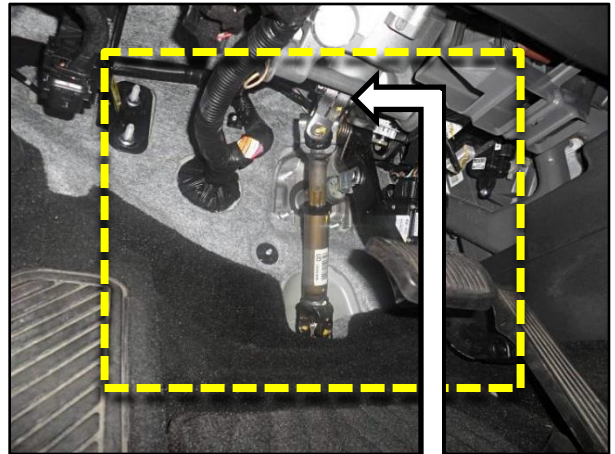
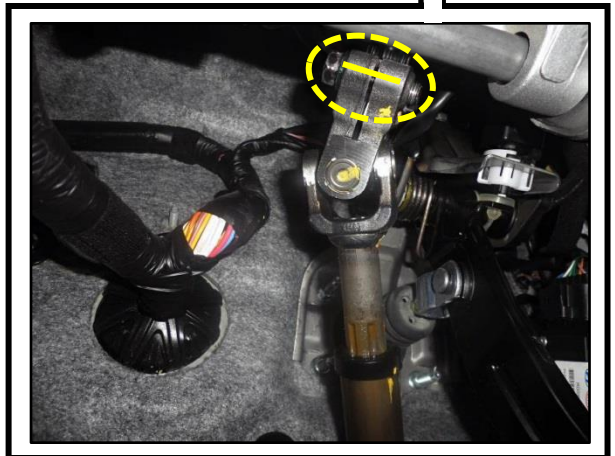
1. Open the driver's door and remove the top bolt from the universal joint. **NOTE:** place a mark across the universal joint to make reinstallation easier.

After disconnecting the universal joint, do **NOT** turn the steering wheel more than 270° to prevent damage to the clock spring.

21.7 ~ 25.7lb-ft (29.4 ~ 34.3Nm)

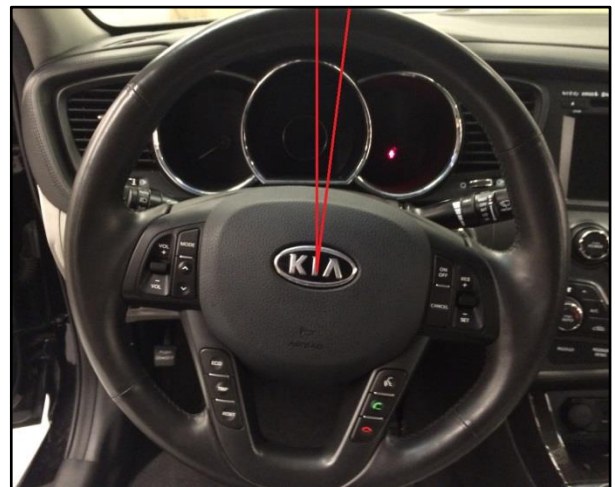
2. Prior to starting the steering effort measurement test (Pg. 3), position the steering wheel slightly to the right, as shown, with the Steering Angle Sensor (SAS) in the positive range. **NOTE:** attempting to start the steering effort test with the SAS in the negative range will trigger an error message and prevent the test from running.

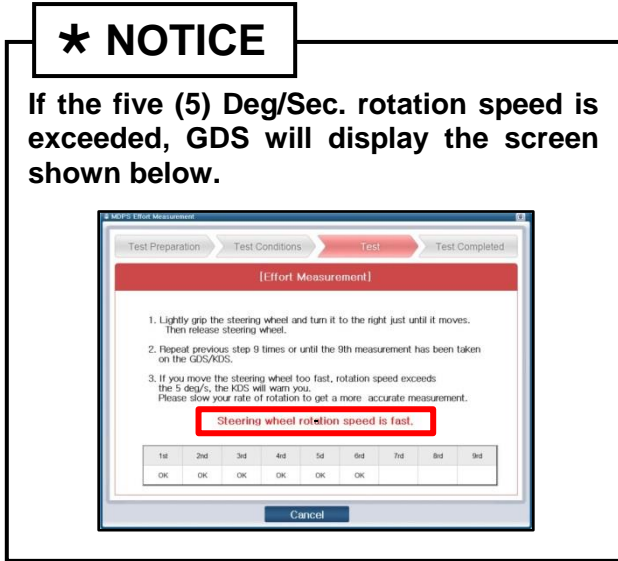
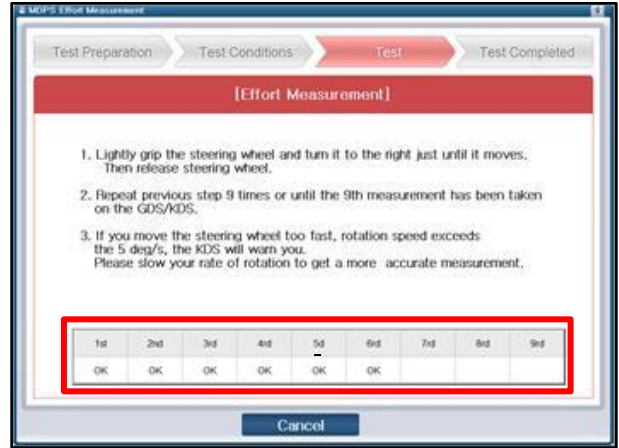
If the five (5) Deg/Sec. rotation speed is exceeded, GDS will display the screen shown below.

- Perform the steering effort measurement test by rotating the steering wheel, slowly, at a speed of 5 Deg/Sec. Repeat the steering effort measurement test a total of nine (9) times.

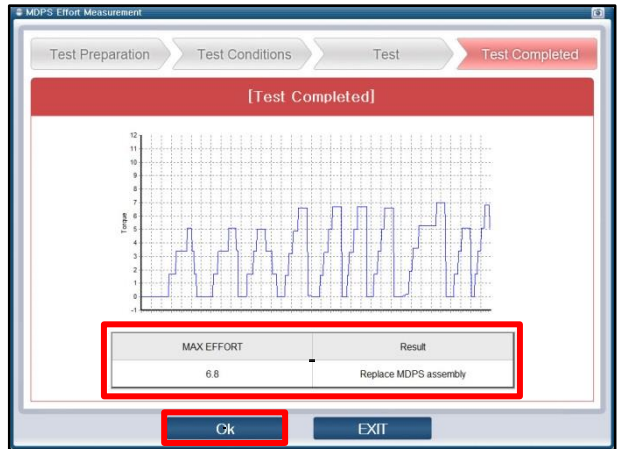
- After performing the steering effort measurement test successfully, GDS will display a result and will provide the appropriate course of action. Click **OK** to continue.

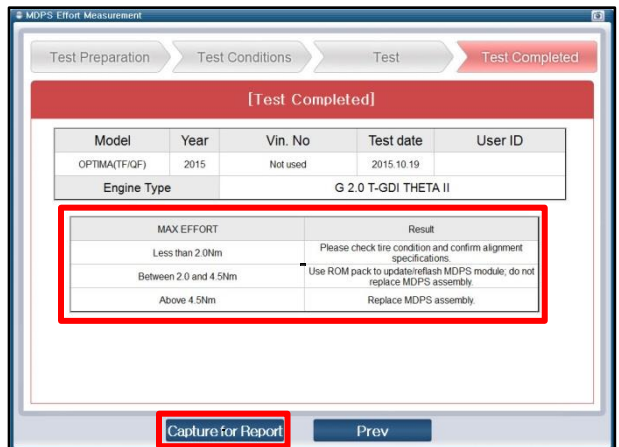
- Refer to the table below for the correct course of action after the 'Test Completed' screen is displayed. **NOTE: hit the 'Capture Report' button to save the report for future reference.**

Item	Max. Effort	Remedy	Proceed to
Steering Effort Value	0 ~ 1.5 lb-ft (0 ~ 2.0 Nm)	No further action is required	N/A
	1.5 ~ 3.3 lb-ft (2.0 ~ 4.5 Nm)	ECU Upgrade	Page 8
	3.3 lb-ft (4.5Nm) or higher	Replace MDPS	Page 11
