GROUP ELE	MODEL 2014~2015MY Sportage (SL)
	NUMBER 092	DATE January 2016
<h2>TECHNICAL SERVICE BULLETIN</h2>		
SUBJECT: SIRIUS AUDIO MUTES (DROPS OUT) INTERMITTENTLY IN OPEN SPACES

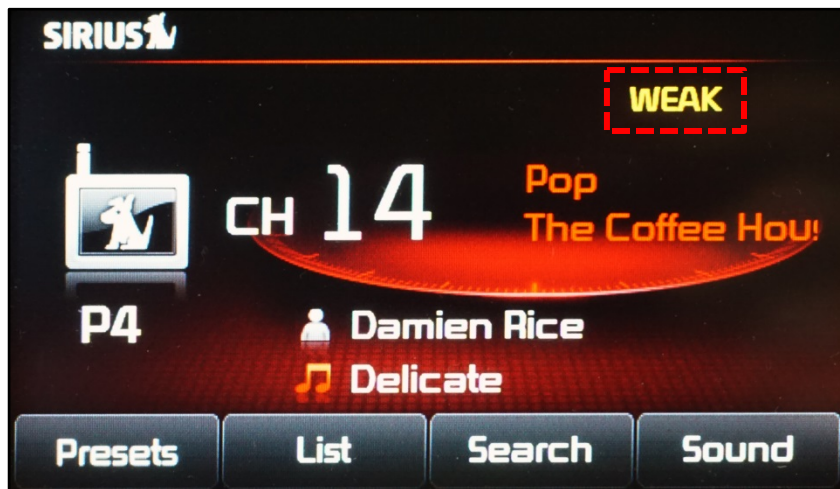
This bulletin provides information about the replacement of the shark-fin style roof antenna of some 2014~2015MY Sportage (SL) vehicles, produced from August 1, 2014 through August 31, 2015, which may exhibit Sirius audio reception concerns (see sample complaints below). Follow the procedure outlined in this bulletin to replace the roof antenna and correct the concern.

- 1- Satellite radio has weak or no signal frequently while driving
- 2- Sirius radio reception cuts in and out often and/or drops out (muting). **NOTE: this condition can occur for time periods longer than 1-2 seconds.**

1. Replace the antenna with an improved one by referring to “Body Electrical System→ Audio→ Antenna→ Repair procedures” chapter in the applicable Workshop Manual.
