MODEL  
2015~2016MY  
Sedona (YP)

NUMBER  
028

## TECHNICAL SERVICE BULLETIN

**SUBJECT:** WINDSHIELD COWL, BLOWER MOTOR AND/OR RESISTOR REPLACEMENT

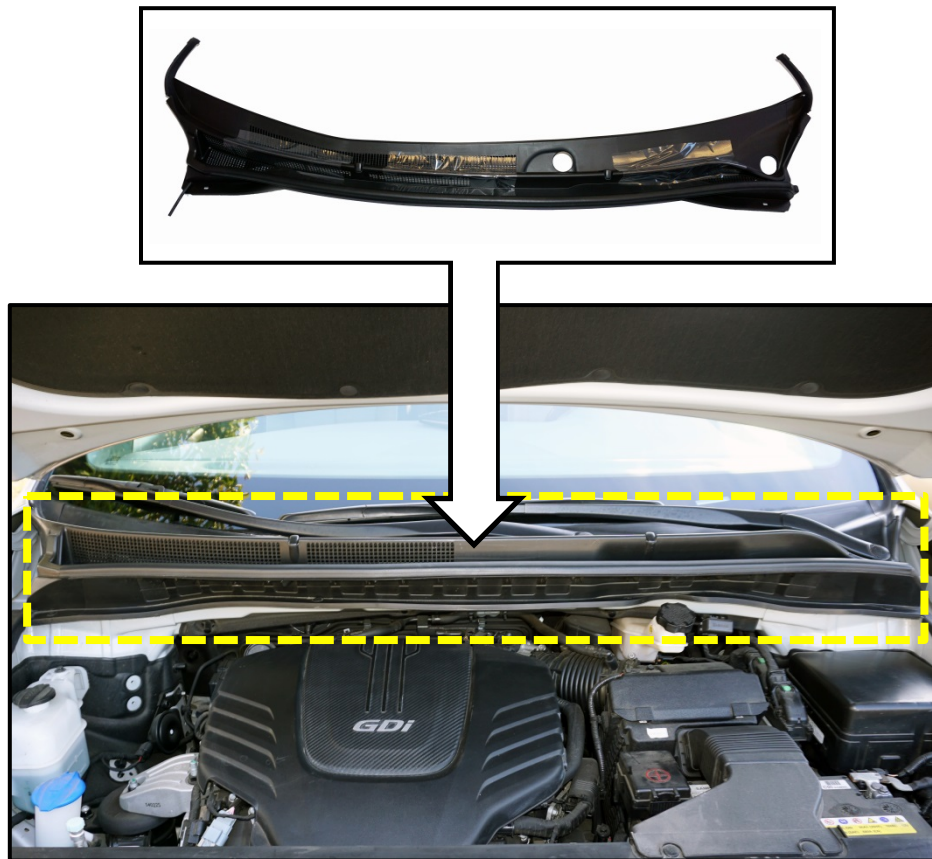
This bulletin provides the procedure for replacement of the windshield cowl, blower motor and/or resistor of some 2015~2016MY Sedona (YP) vehicles, produced from Job #1 through June 16, 2015, which may exhibit a slow or inoperative blower motor as a result of freezing up due to intrusion of snow/ice into the HVAC ducting. To correct this concern, replace the cowl and, if necessary, the blower motor and/or resistor, by referring to the information included in this service bulletin.
