TECHNICAL BULLETIN
JTB00392NAS3
27 JUN 2016

SECTION: 303-14

Engine MIL Illuminated

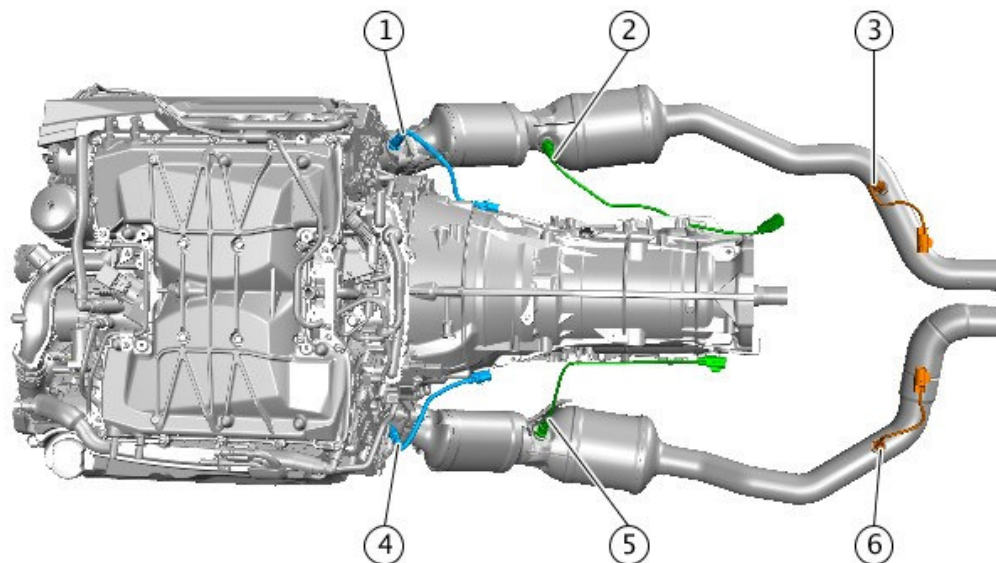
E181489

Heated Oxygen Sensor (HO2S) location and designation.

HO2S	DESCRIPTION	IDENTIFICATION
1	HO2S Heated Oxygen Sensor - Pre-catalyst - Bank 1, sensor 1	B1-S1

HO2S	DESCRIPTION	IDENTIFICATION
2	HO2S Heated Oxygen Sensor - Mid-catalyst - Bank 1, sensor 2	B1-S2
3	HO2S Heated Oxygen Sensor - Post-catalyst - Bank 1, sensor 3	B1-S3
4	HO2S Heated Oxygen Sensor - Pre-catalyst - Bank 2, sensor 1	B2-S1
5	HO2S Heated Oxygen Sensor - Mid-catalyst - Bank 2, sensor 2	B2-S2
6	HO2S Heated Oxygen Sensor - Post-catalyst - Bank 2, sensor 3	B2-S3

**NOTE: Only the affected Heated Oxygen sensor(s) should be replaced as indicated by the Diagnostic Trouble Code(s) (DTC) stored in the Powertrain Control Module (PCM); refer to Diagnostic Trouble Code (DTC) Table. It is very unlikely for both sensors to fail simultaneously. The new software will prevent any further concerns.**

- If no listed DTC(s) is stored in the Powertrain Control Module (PCM), continue to the next step to update the PCM software.
- If one or more of the listed DTCs is stored in the PCM, replace only the relevant Heated Oxygen sensor(s) (HO2S) indicated by the stored DTC (see TOPIX Workshop Manual section 303-14).
