No.: 16 TS-17  
August 17, 2016

SUBJECT: **GHG17 DD Platform Ambient Air Temperature Sensor and Fault Codes**  
**SPN 1636/FMI 16 - Charge Air Cooler Efficiency Low and/or SPN**  
**171/FMI 20 - Ambient Temperature Sensor Signal Not Plausible**

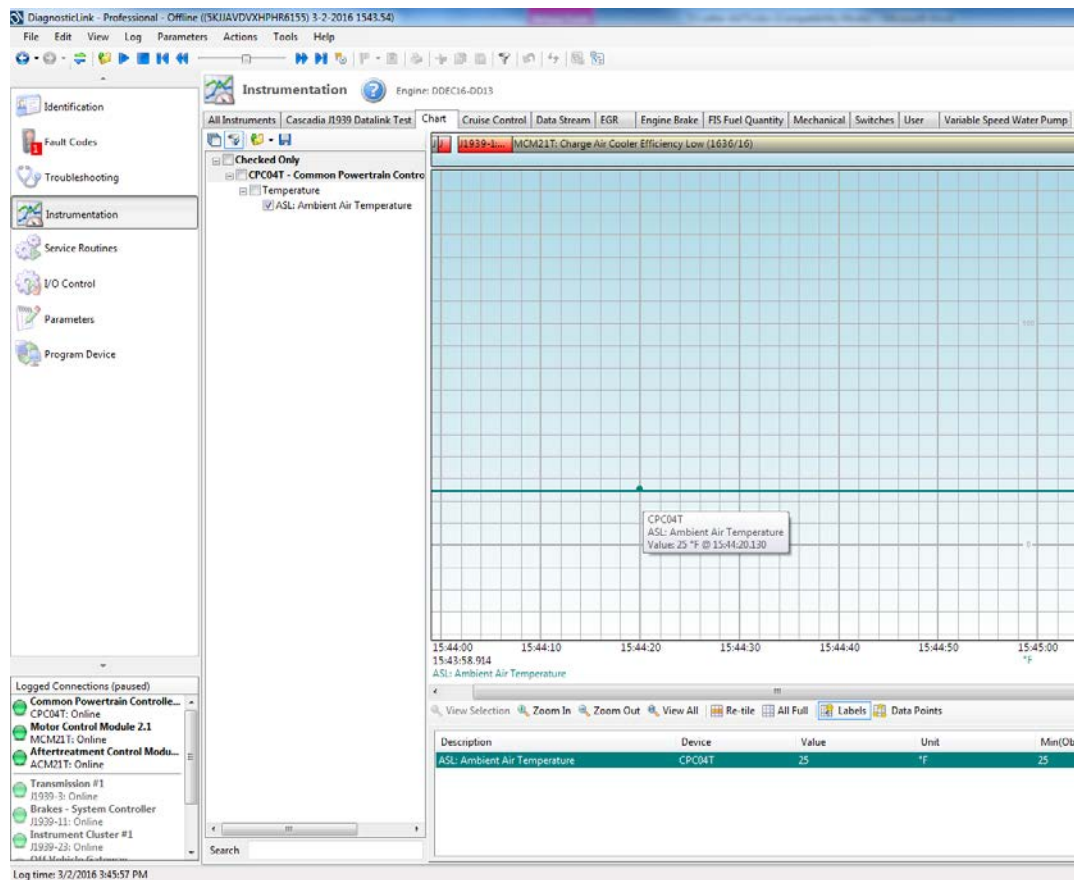
Some trucks are logging fault codes SPN 1636/FMI 16 - Charge Air Cooler Efficiency Low and/or SPN 171/FMI 20 - Ambient Temperature Sensor Signal Not Plausible.

The cause of the fault codes is due to an incorrect Ambient Air Temperature Sensor installed by the vehicle OEM.

Check the Ambient Air Temperature Sensor reading in DiagnosticLink<sup>®</sup>. It can be viewed in the chart function under the CPC module by viewing "ASL: Ambient Air Temperature". Note that there are other Ambient Air Temperature Sensor readings from other modules that may not be correct - do not use them. The incorrect sensor will typically read about 17°C (30°F) colder than the actual ambient air temperature. See Figure 1 where the log file shows the Ambient Air Temperature Sensor was reading -4°C (25°F) but the actual temperature at the repair shop was over 16°C (60°F).

**Figure 1 – DiagnosticLink Log File with Incorrect Ambient Air Temperature Sensor**

If the Ambient Air Temperature Sensor reading is incorrect, inspect the sensor. The correct sensor is P/N: 23518328. The part number is noted on the sensor itself for easy identification. If the sensor is incorrect, replace it. See Figure 2 for an example of the correct sensor.

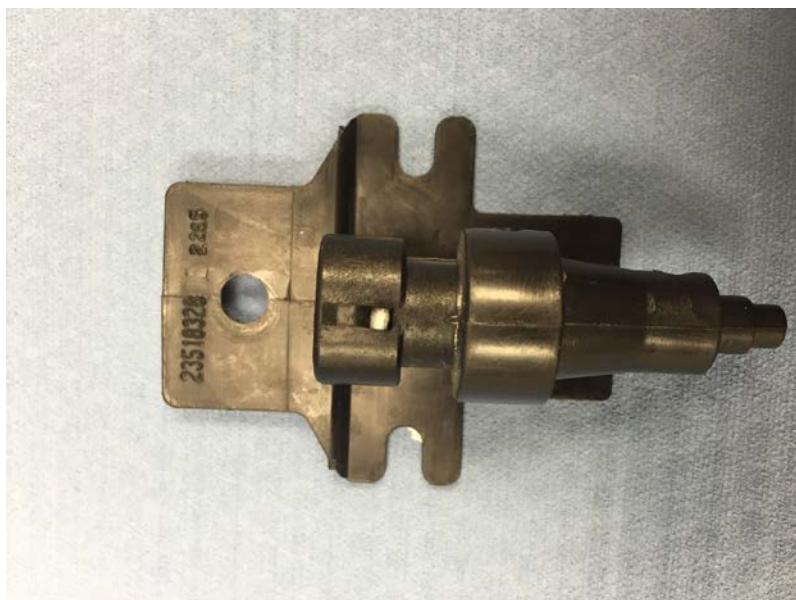
**Figure 2 – Correct Ambient Air Temperature Sensor P/N: 23518328**

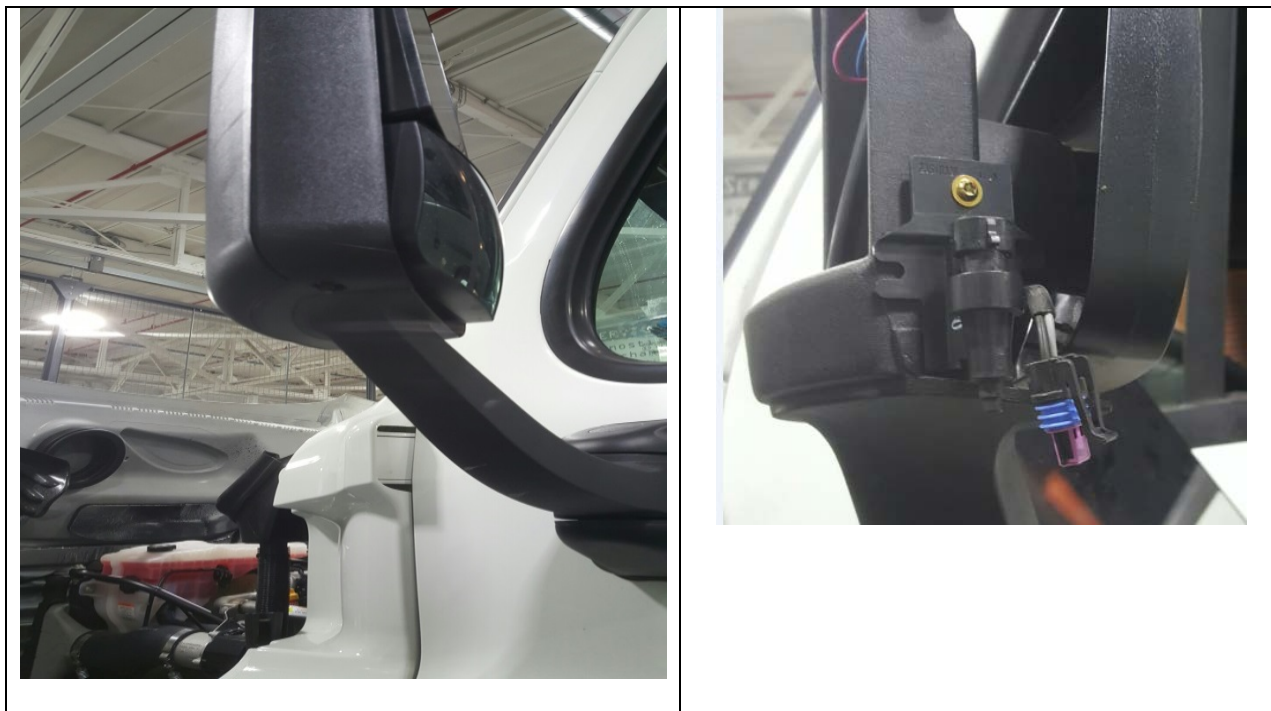
Freightliner Cascadia and Coronado chassis have the sensor installed in the driver side mirror. See Figure 3. Western Star 5700XE chassis have the sensor installed inside the passenger side mirror. See Figure 4. Western Star 4700/4900 chassis have the sensor installed above the passenger side mirror in a small metal junction box. See Figure 4.

**Figure 3 – Sensor Location in Cascadia and Coronado Chassis**

Follow the applicable repair procedure in the chassis OEM service manual for replacing the sensor.

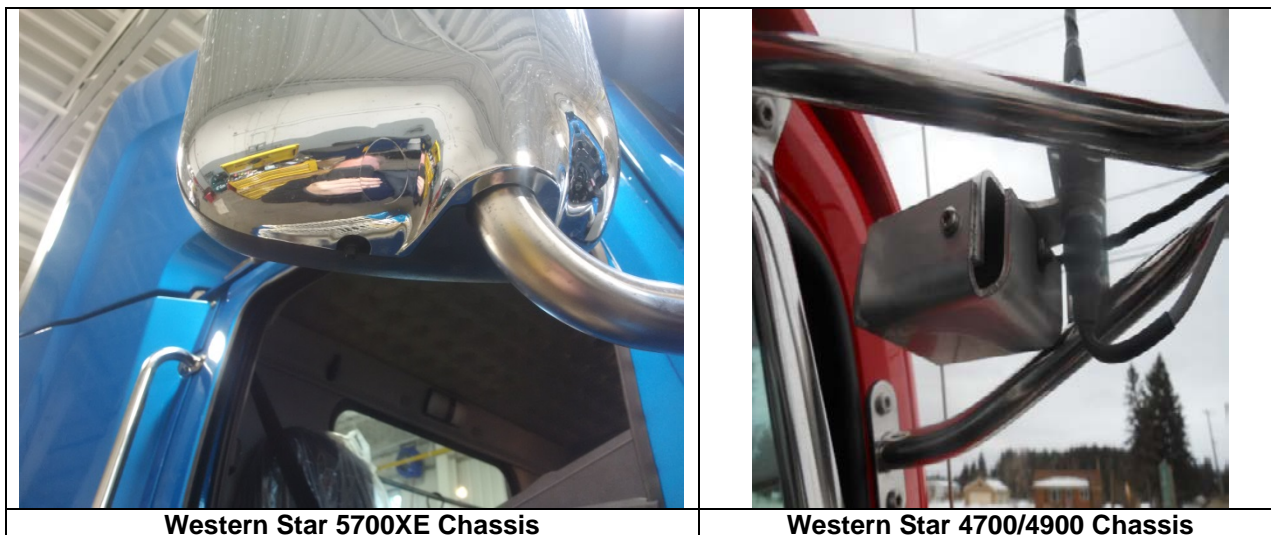
**Western Star 5700XE Chassis**

**Western Star 4700/4900 Chassis**

**Figure 4 – Sensor Location in Western Star Chassis**
