Service Bulletin

PRELIMINARY INFORMATION

Subject: (Malibu HEV) High Voltage Drive Motor Battery TAC Restriction and Exchange Program

Models: 2016-2017 Chevrolet Malibu Hybrid
With RPO HP4

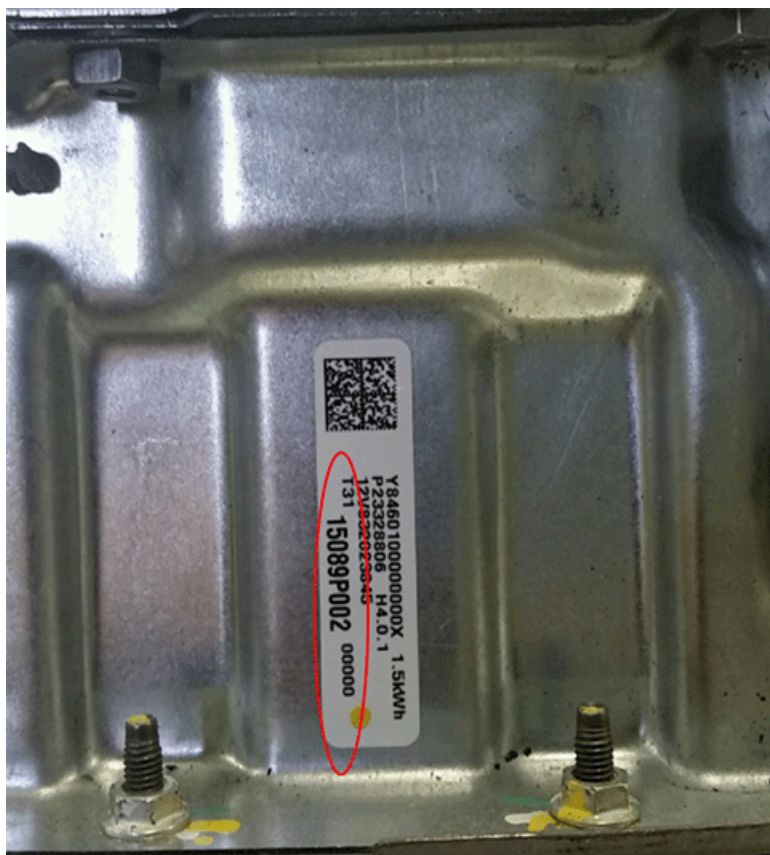
6.1 The battery has a battery identification tag that is located on the side of the battery. Locate the tag and record the 16 digit battery identification number (BIN). The BIN is the bottom most number on the label and it starts with a "T" indicator (See Photo Below). If the battery is not out of the vehicle yet, you can find the BIN by installing the MDI and using GDS 2. Access the Hybrid Powertrain Control Module 2 data list and look under the identification information section and the sixteen digit number will be listed under the parameter: Hybrid/EV Battery Pack Identification Number.
