Bulletin No.: PIP5416

Subject: Instrument Panel Cluster (IPC) Warning Lamps And / Or MIL Are Illuminated Diesel Exhaust Fluid (DEF)
Message Displayed Various DTCs Set (Inspect Wiring Harnesses for Chafing).

Brand:	Model:	Model Year:		VIN:		Engine:	Transmission:
		from	to	from	to		
Chevrolet	Colorado	2016	2016	All	All	2.8 LWN	All
GMC	Canyon	2016	2016	All	All	2.8 LWN	All

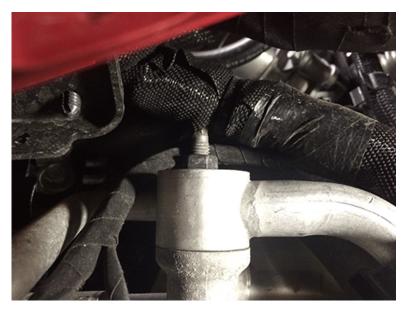
Air Conditioning (AC) compressor, AC compressor suction and discharge line manifold, AC line and AC compressor clutch.

Concerns in the area of the AC compressor, lines or suction / discharge pipes may cause:

DTCs associated with chaffing in this area include:

B127E, C0306, C0321, C0398, C0800, P0117, P0119, P0340, P0341, P0406, P0483, P0522, P0628,

P0641, P06A3, P0700, P20BB, P20BF, P227E, P24B1, U0073, U0077, U0121, U0131, U0140,

U0151, U0415, U2099, u0401, U0415 and U0420.

If you encounter these scenarios, inspect, repair (as necessary) and route the wiring harness away from these possible chafe points.

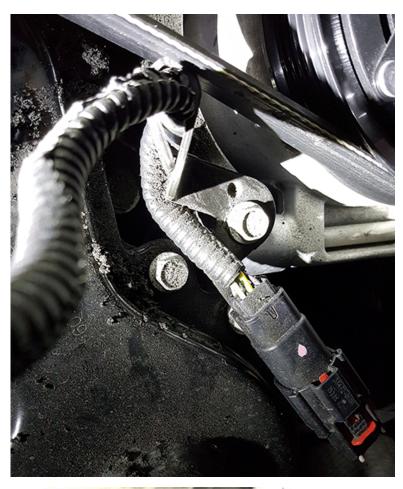
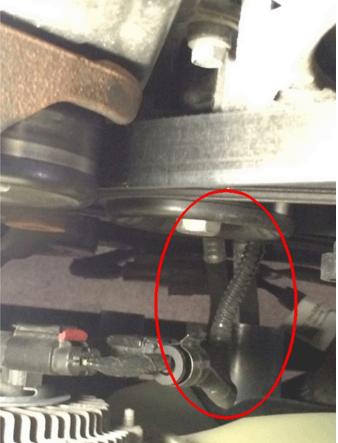
Serpentine Belt. The fan clutch wiring harness support bracket may be out of position allowing the harness to run on the belt.

Concerns in the area of the serpentine belt may cause: Various IPC warning lights to illuminate.

DTCs associated with chafing in this area may include:

C0273, P0526, P0480, P0336, P0526, P0641 and P0651.

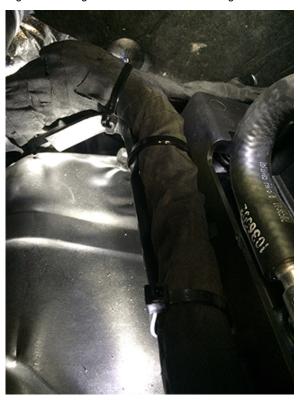
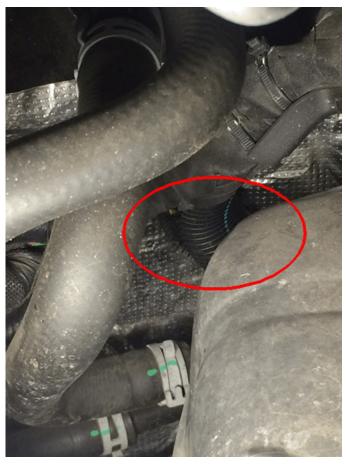
Right rear of engine. Check for harness damage on the exhaust heat shield as described in the latest version of bulletin 16-NA-081.

Concerns in the area of the right rear of engine / exhaust heat shield may cause:

Dtcs associated with chafing in this area may include:

B1011, C0306, P0201, P0202, P0203, P0204, P0410, P0575, P062D, P0697, U0073, U0100, U0121, U0140, U0415 and U0420.

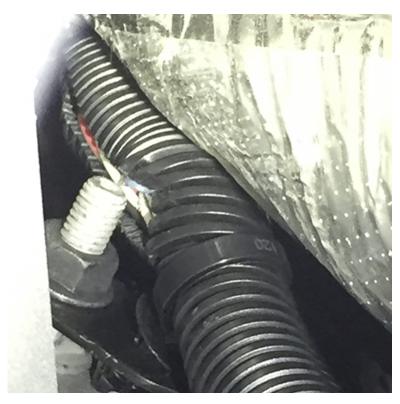
Transmission bell housing bolt / stud.

Concerns in the area of the rear of engine / transmission bell housing bolt / stud may cause:

DTCs associated with chaffing in this area may include:

P0201, P0202, P0203, P0204, P0392, P0401, P0420, P062D and U0073.

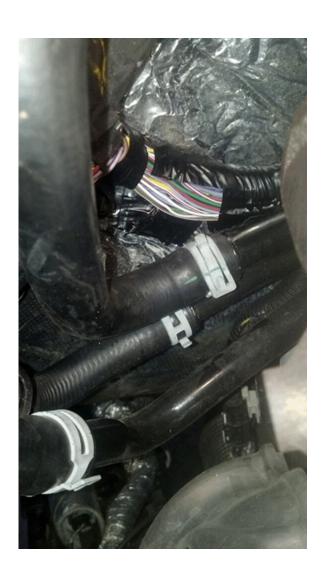
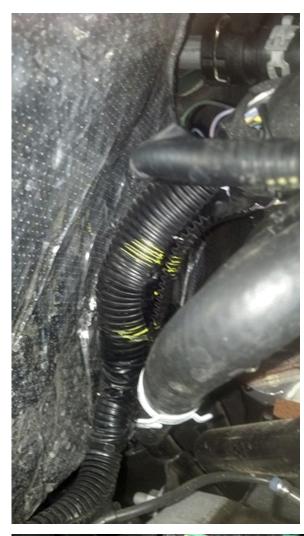
Coolant pipe and clamp tabs between engine and cowl.

Concerns in the area of the coolant pipe / clamp / clamp tabs between engine and cowl may cause:

DTCs associated with chafing in the area may include:

$B1011,\, P0575,\, U0073,\, U0100,\, U0121,\, U0140,\, U0415\,\, and\,\, U0420.$

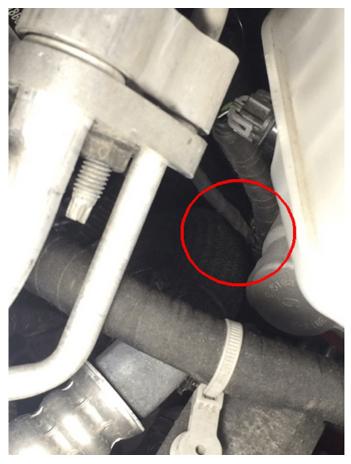
Near the brake fluid level switch.

Concerns in the area near the brake fluid level switch may cause:

DTCs associated with chafing in this area may include:

C0273 and P0641.

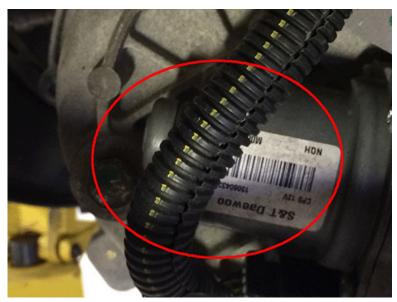
Transfer case encoder motor.

Concerns in the area near the encoder motor on the transfer case may cause:

Dtcs associated with chafing in this area may include:

## C0396.
