Technical product information

Topic	Audio amplifier failure - water leak
Market area	Bentley: worldwide (2WBE),Hongkong-Macau (5HK)
Brand	Bentley
Transaction No.	2044285/1
Level	EH
Status	Approval
Release date

Mulsanne

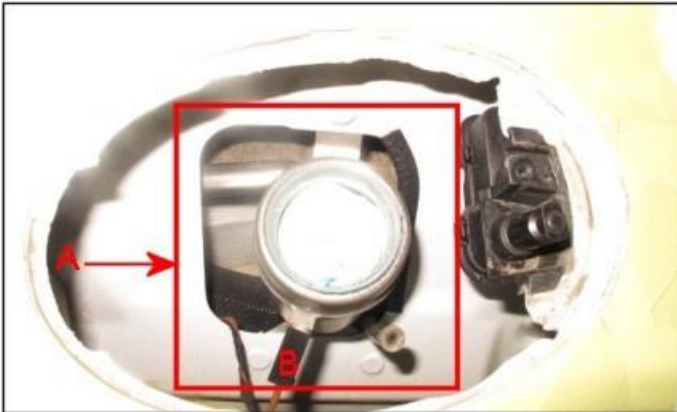
Figure 1

Water entering via fuel filler bowl may contaminate the audio amplifier

2. Clean surface of inner panel (A) in preparation for affixing water deflector (see Figure 1)
3. Disconnect earth wire (B) from fuel filler neck (see Figure 1)
